## Report Summary Page

This is only a summary of the inspection report and is not a complete list of discrepancies.

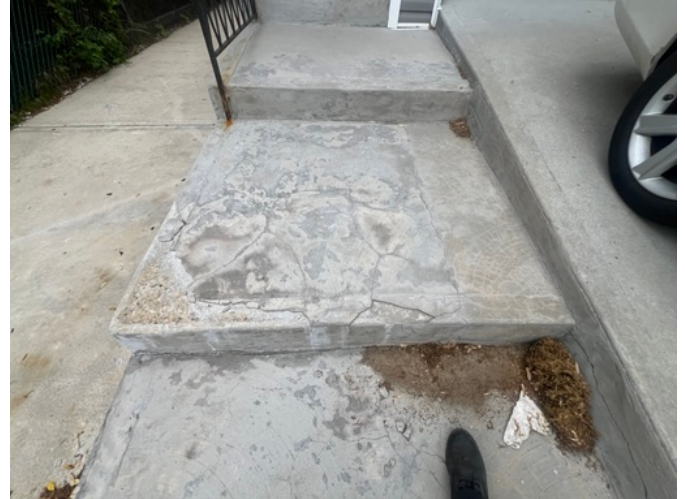
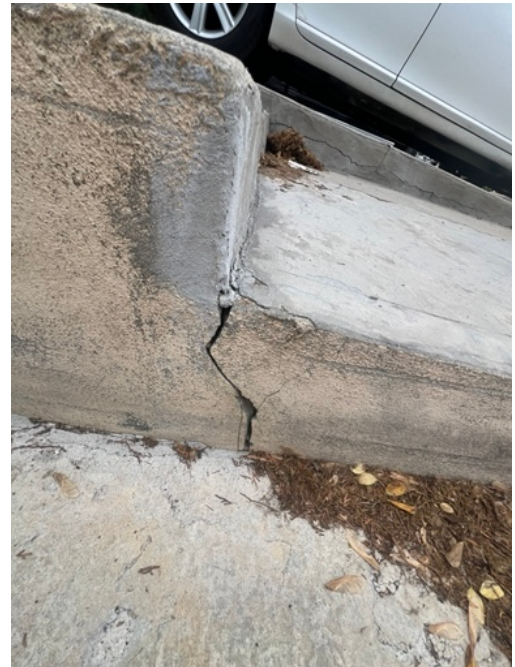
#### 2.1 Front Entrance Conditions (Repair)

Minor settlement was observed at the porch. Although no immediate concern was observed at the time of inspection, recommend sealing along wall, or any settled areas. Over time, settlement can cause water penetration at the house wall. No railings were present. For increased safety, client should consider installation of a railing. Client should consult with a qualified contractor for information on current standards.

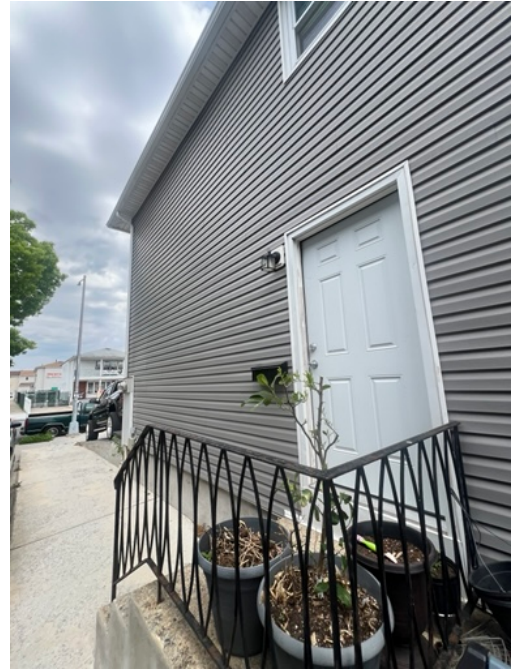
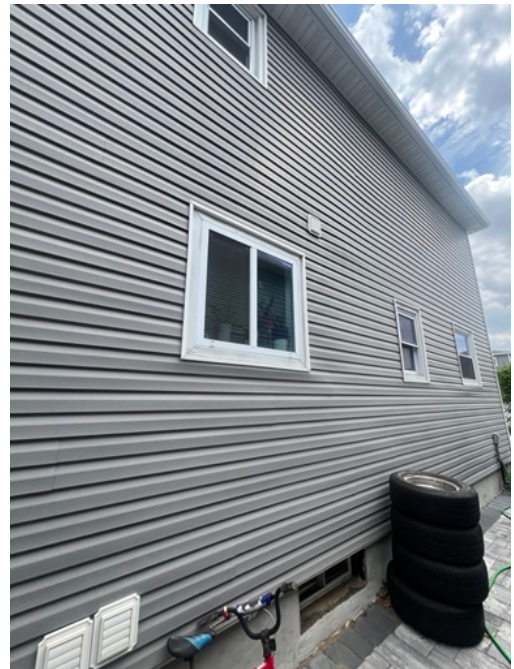
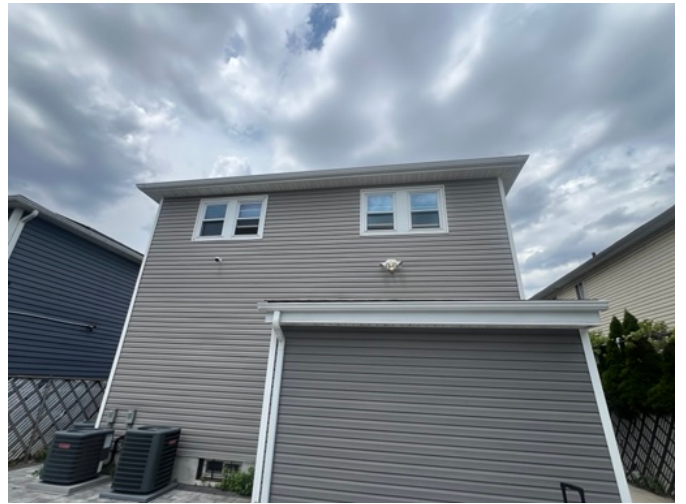
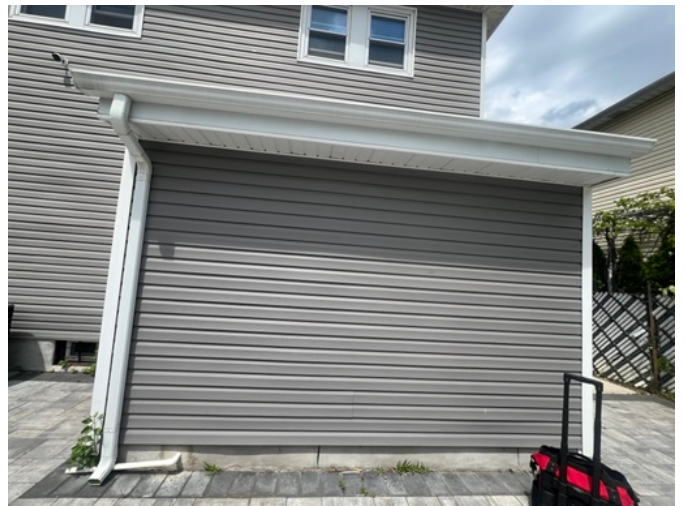
### **2.3 Exterior Wall Conditions (Repair)**

Missing Soffits Underneath Front Porch Area and bump out on east side. Vegetation was in contact with the exterior walls. The vegetation should be trimmed away 1 - 2 feet from the wall. The exterior walls were not fully visible due to overgrown vegetation.

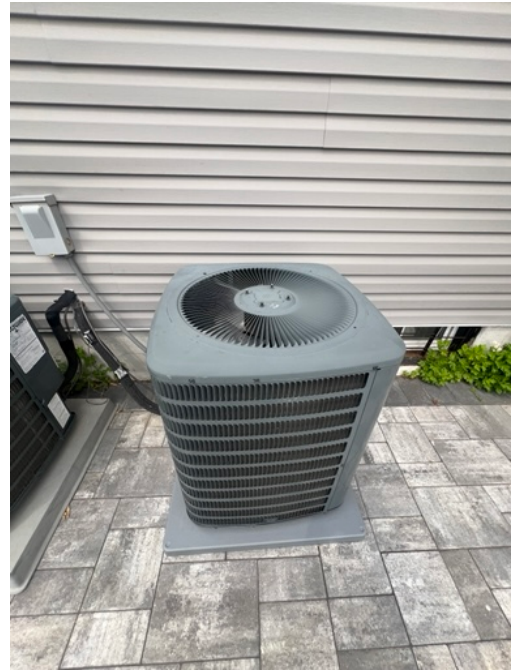
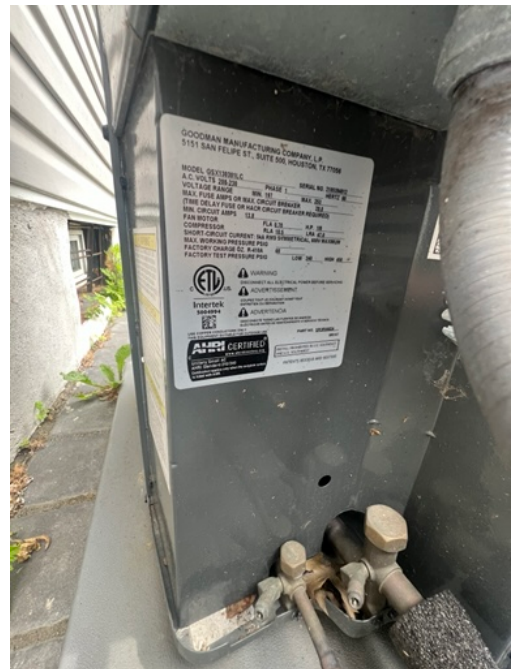
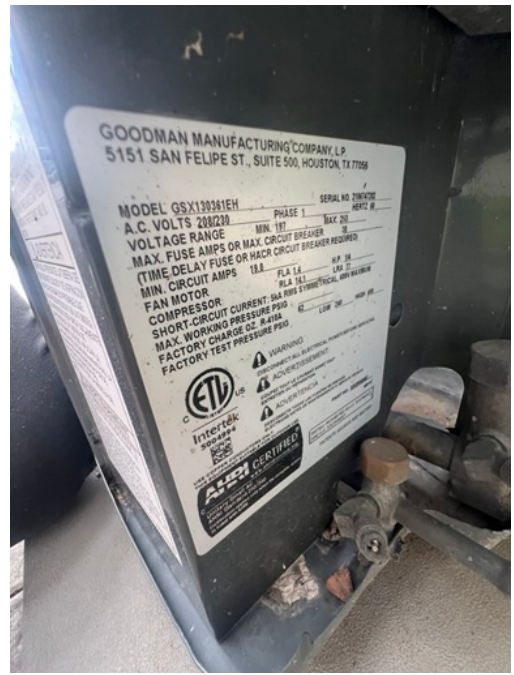
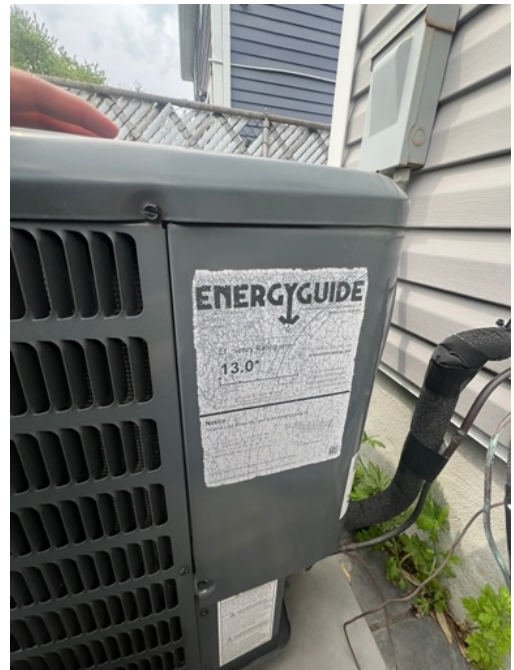
### 4.5 AC Unit Conditions (Repair)

The air handler appears to be from 2015 and was operational at the time of inspection. An unusual noise was noted from the air handler or blower fan during operation. Service and further evaluation by a qualified HVAC contractor is recommended.

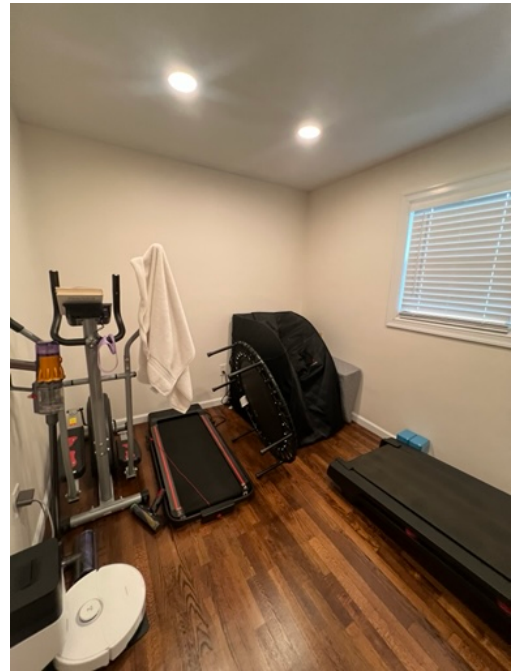
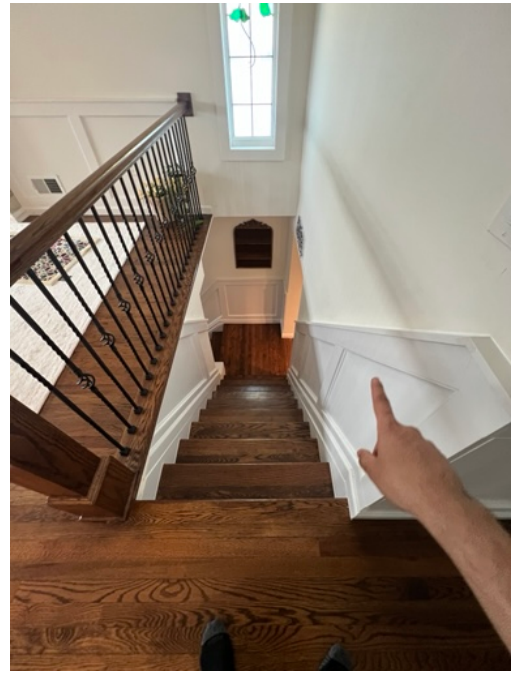
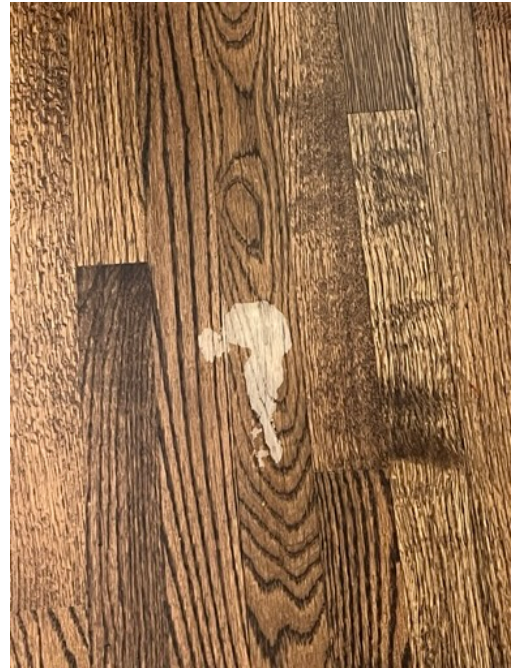
### 7.3 Floor Conditions (Repair)

The floors squeaked at second floor. Recommend securing floorboards and / or repair as needed.

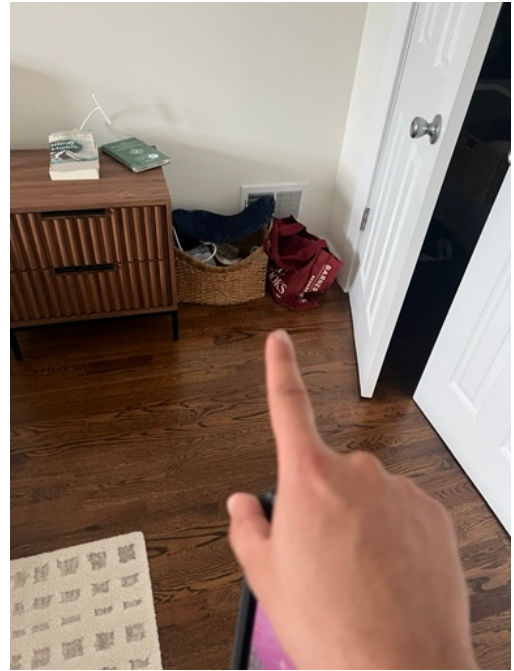
#### **7.4 Heat Source Conditions (Repair)**

Low air volume / flow was noted in bedroom on second floor. Recommend further evaluation by a qualified heating contractor.

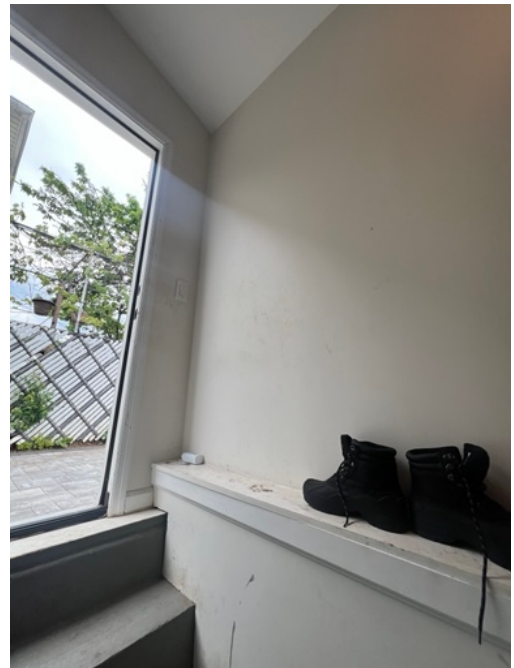
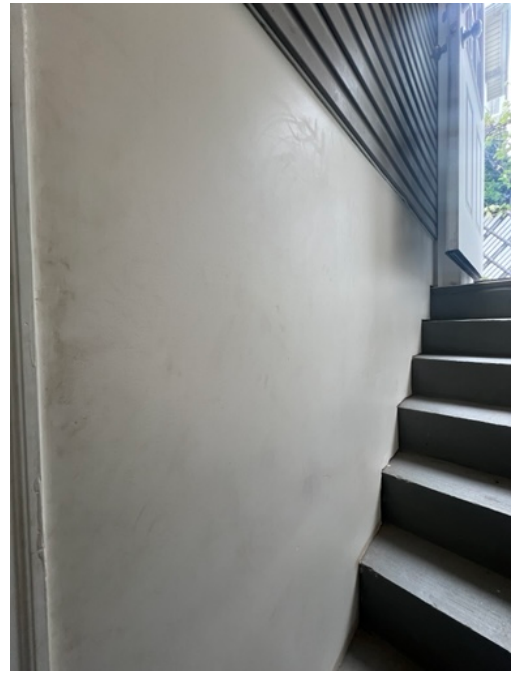
### 10.1 Basement Stair Conditions (Repair)

The stair railing was missing or not installed. Recommend installation of railings as a safety measure.

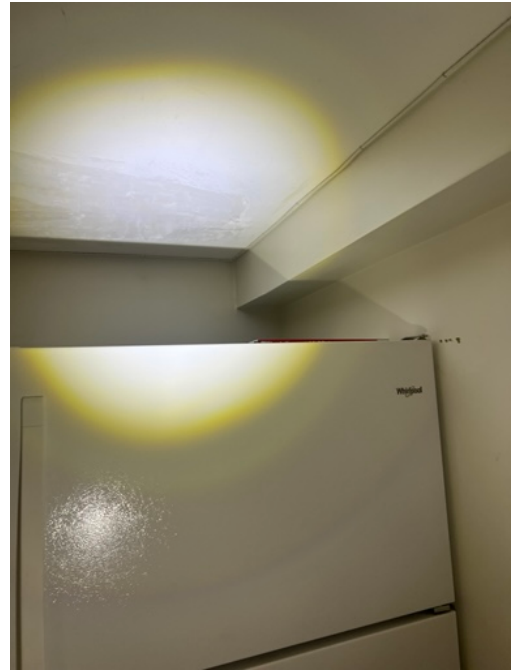
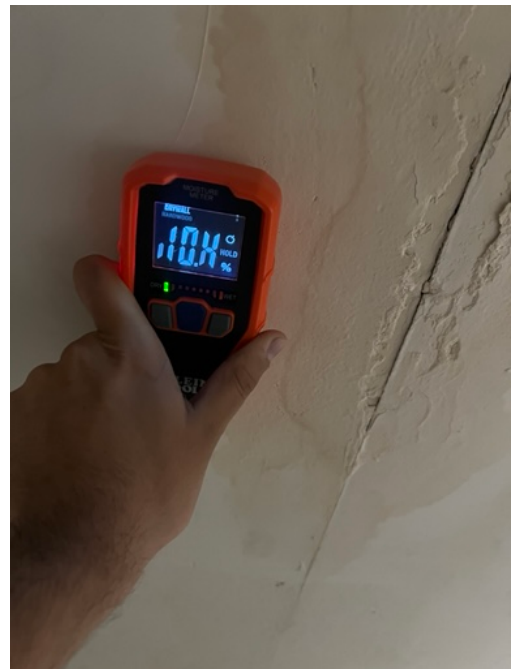
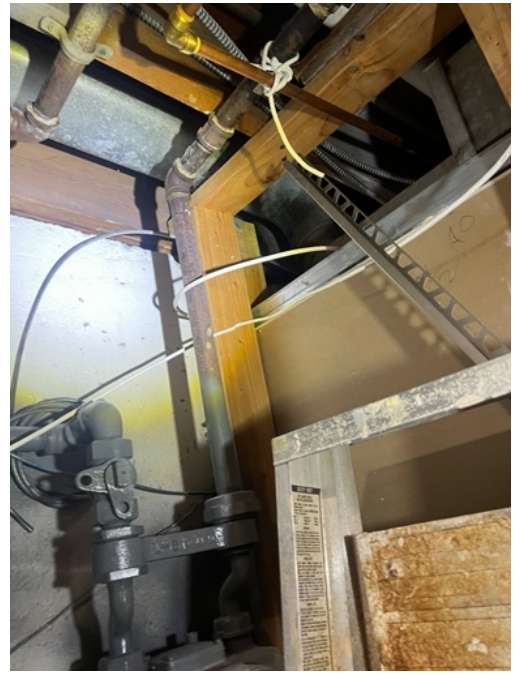
### 12.2 Flooring Support Conditions (Repair)

Evidence of past leakage was noted in the basement utility room at the time of inspection. Waterproofing or prior repair measures also appear to be present. The area should be monitored and repaired further as needed.

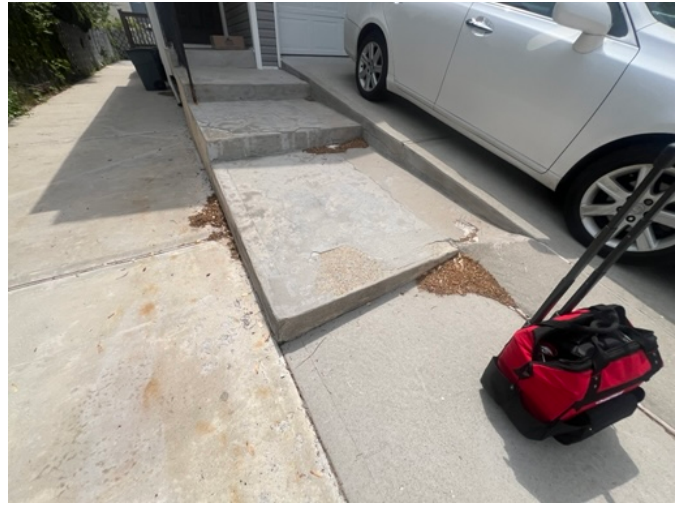
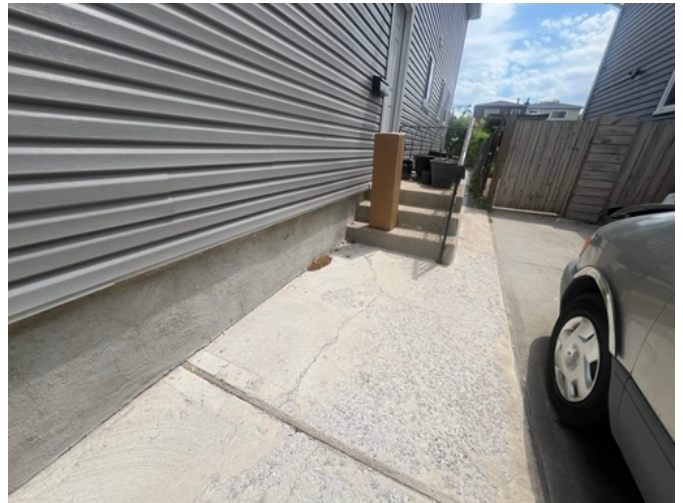
#### 1.2) Driveway Conditions

The driveway has some surface erosion and minor deterioration.

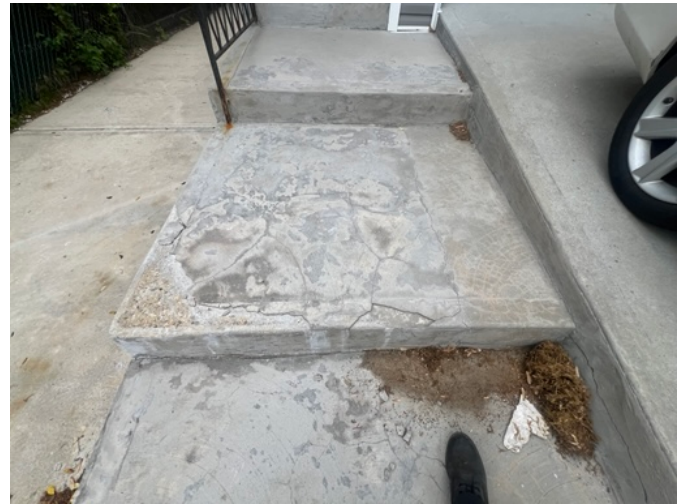
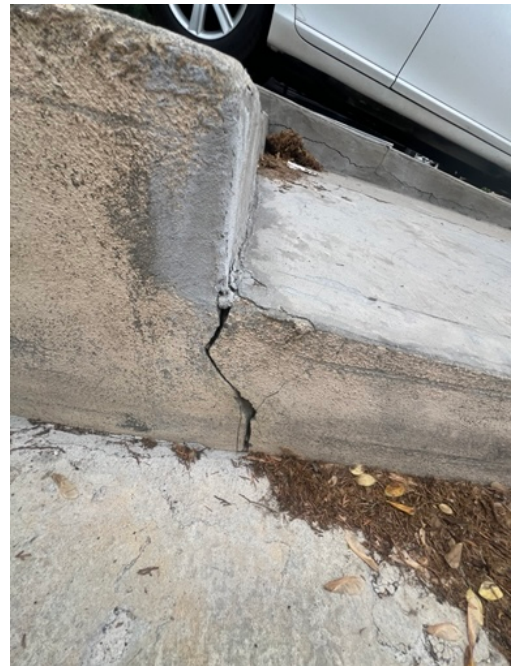
#### 2.1) Front Entrance Conditions

Minor settlement was observed at the porch. Although no immediate concern was observed at the time of inspection, recommend sealing along wall, or any settled areas. Over time, settlement can cause water penetration at the house wall. No railings were present. For increased safety, client should consider installation of a railing. Client should consult with a qualified contractor for information on current standards.

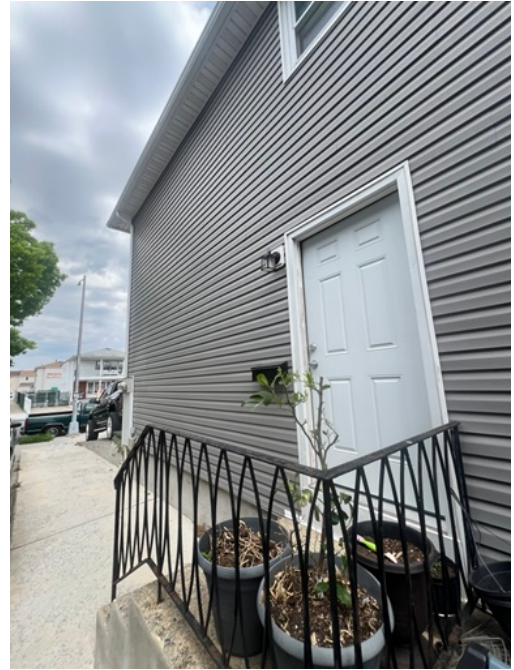
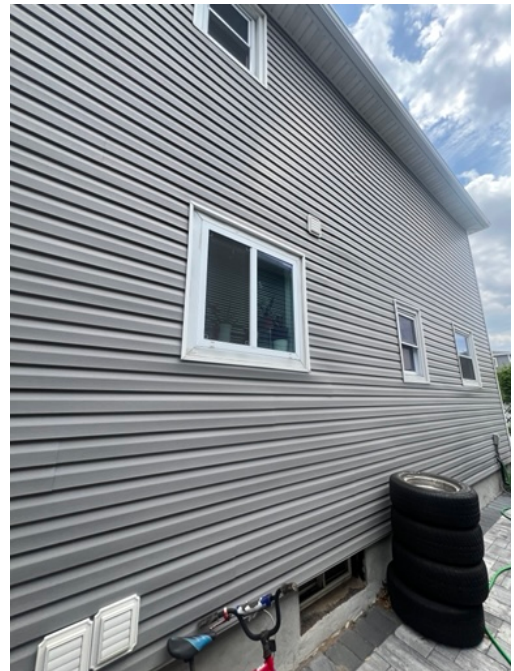
2.3) Exterior Wall Conditions

Missing Soffits Underneath Front Porch Area and bump out on east side. Vegetation was in

contact with the exterior walls. The vegetation should be trimmed away 1 - 2 feet from the wall. The exterior walls were not fully visible due to overgrown vegetation.

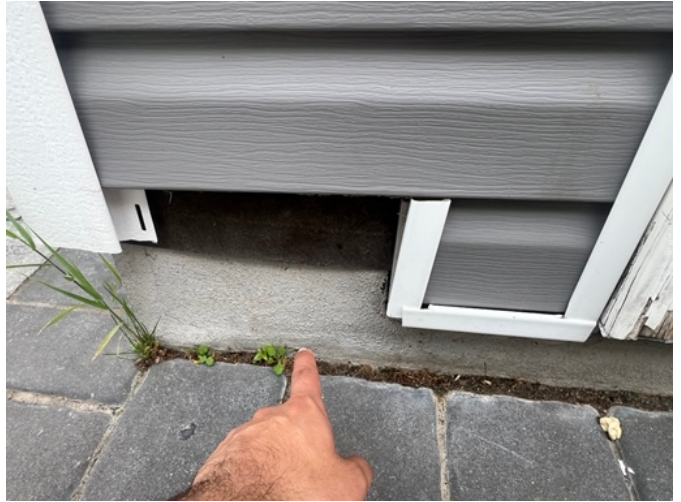
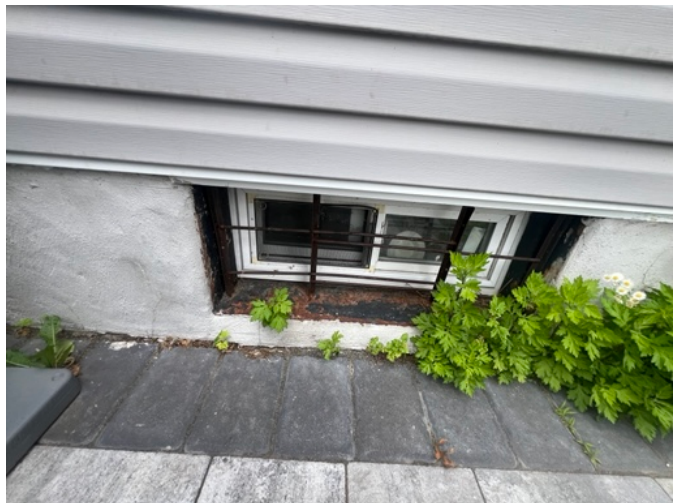
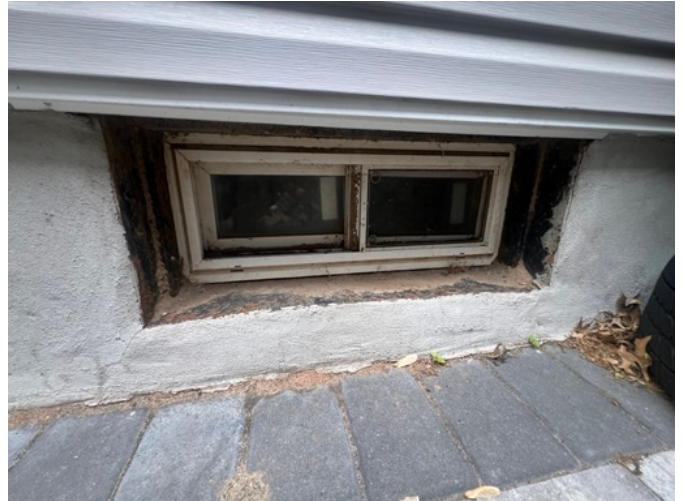
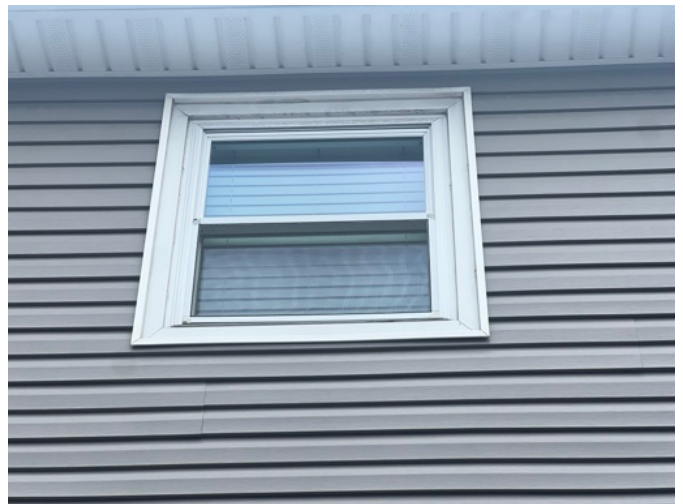
**2.4) Window Conditions**      AS

Exterior frame weathering and some deterioration was observed on basement windows.  
Remaining Windows Appears Serviceable.

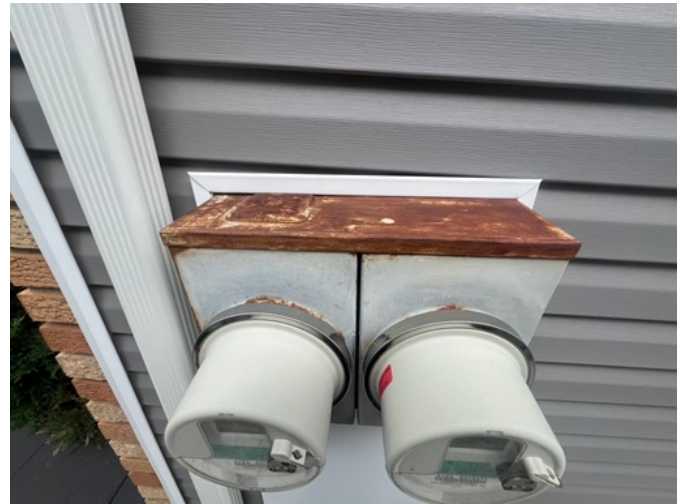
#### 5.1) Electrical Service Conditions

Corrosion was observed. Recommend maintenance as needed.

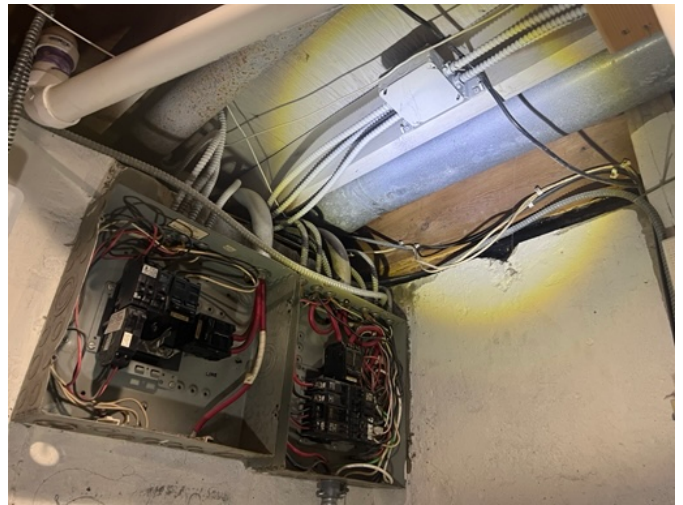
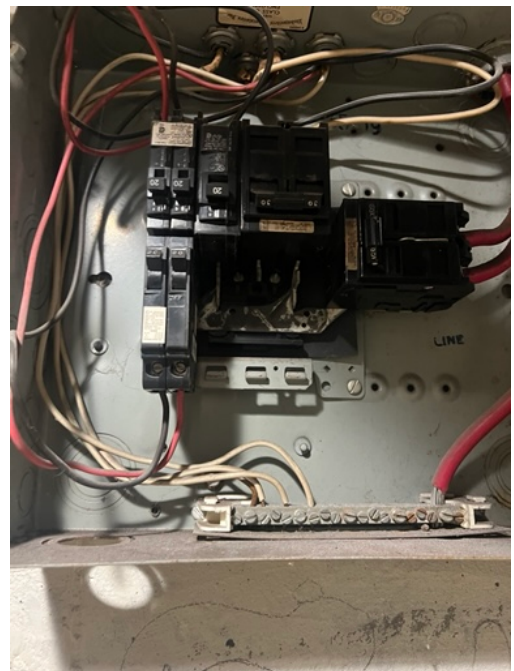
## 5.3) Electrical Panel Conditions

One main panel with a pass through and a subpanel were present at the time of inspection. The panels appeared generally serviceable in the visible areas. Panel covers should be installed or secured as needed for proper safety.

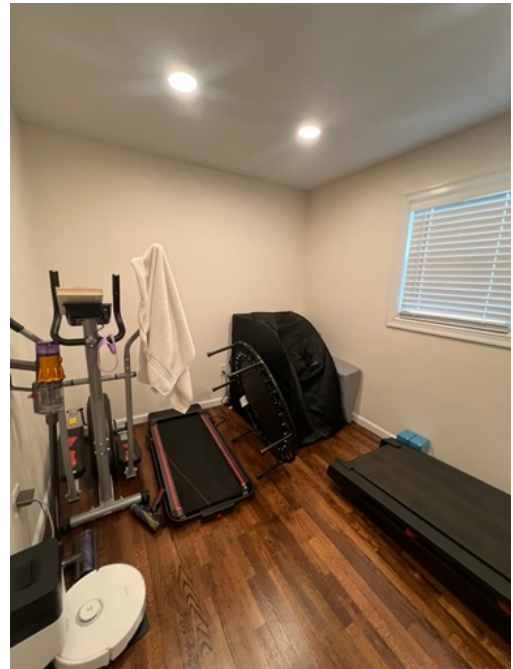
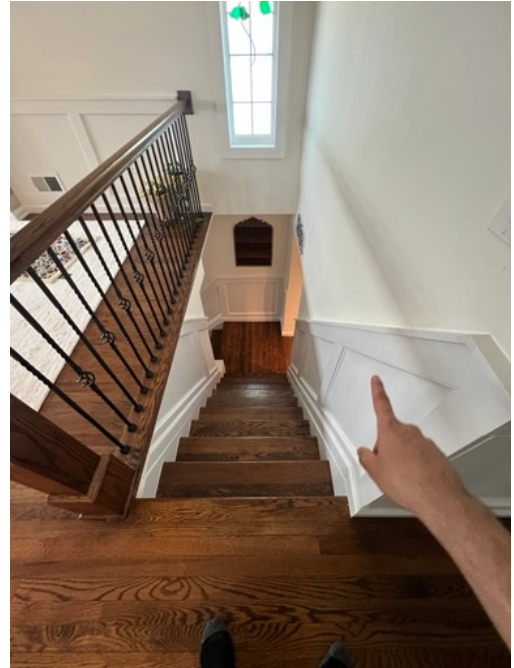
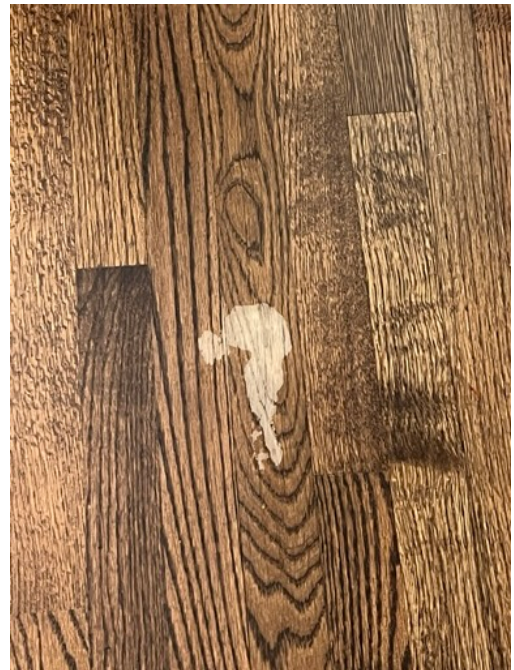
#### 7.3) Floor Conditions

The floors squeaked at second floor. Recommend securing floorboards and / or repair as needed.

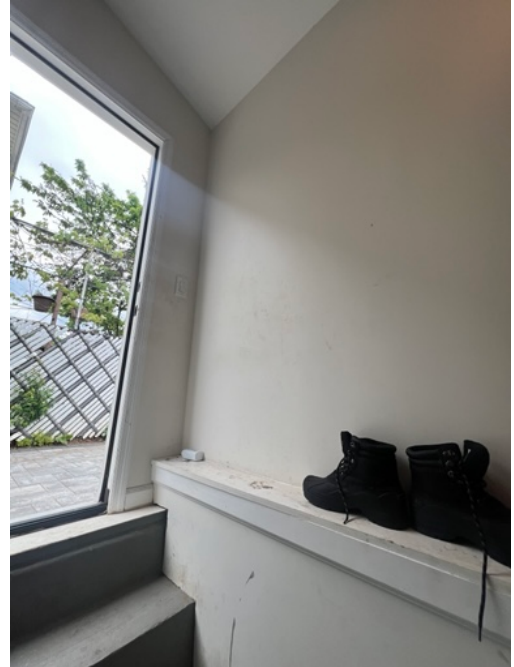
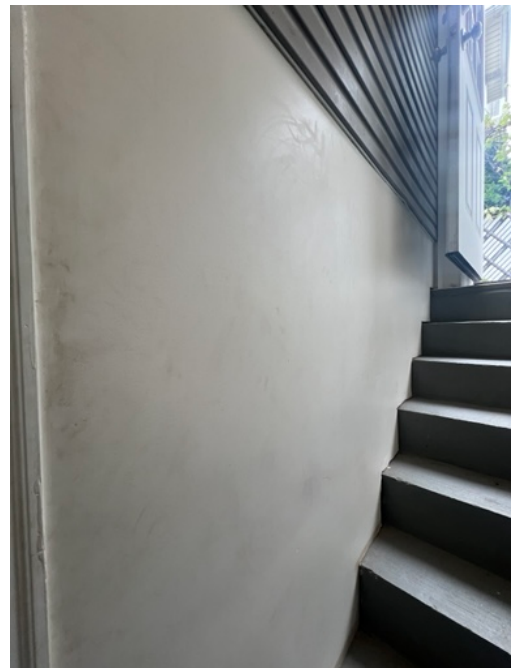
**10 Basement****Walls - Ceilings - Floors****10.1) Basement Stair Conditions****R**

The stair railing was missing or not installed. Recommend installation of railings as a safety measure.

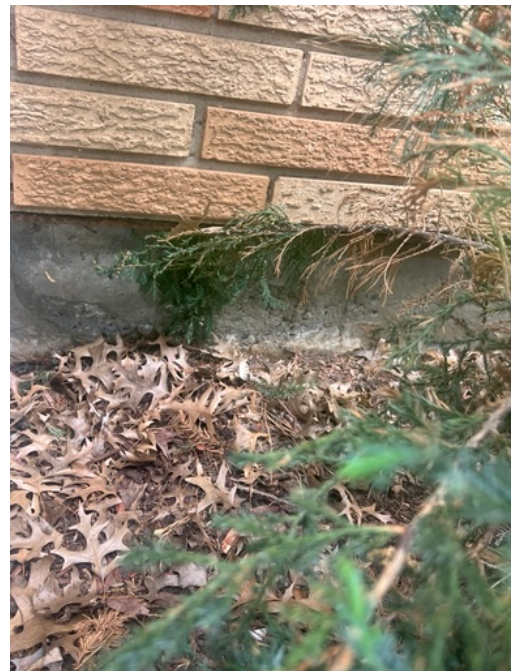
#### 12.1) Foundation Conditions

A crack of approximately 1/8" or less was observed in the foundation wall. The cracking implies that some foundation movement has occurred. Recommend masonry sealing and monitoring for any further movement. Although no obvious evidence suggesting "immediate" concern was observed, this does not however guarantee future conditions. The exact / precise measurement of such conditions is not within the scope of our inspection. Past or future movement may be related to soils and geological issues, which are beyond the scope of our expertise.

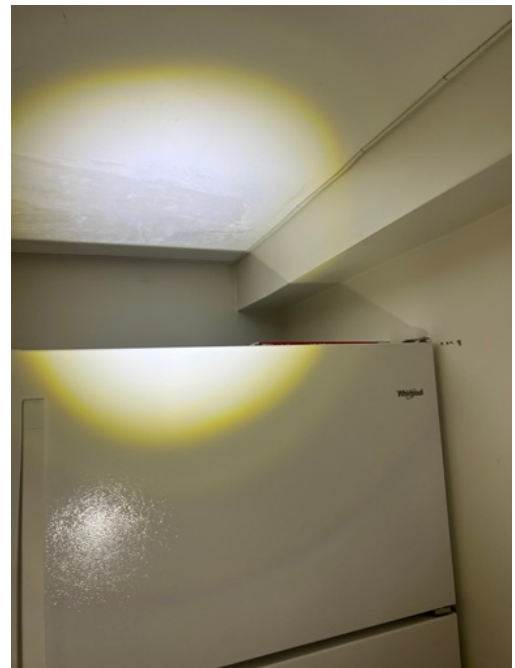
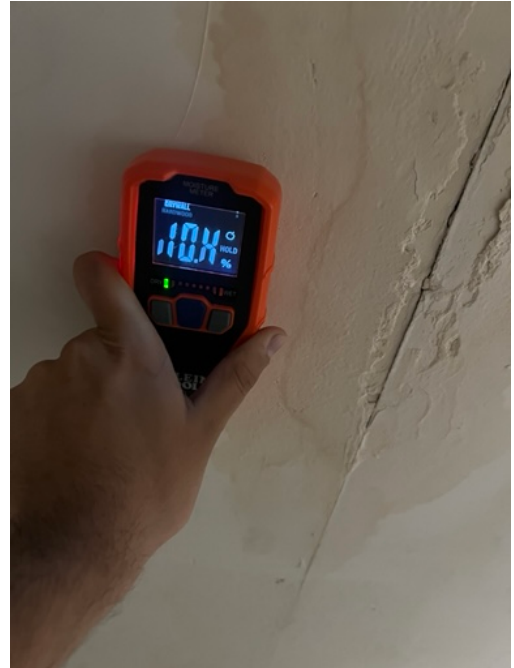
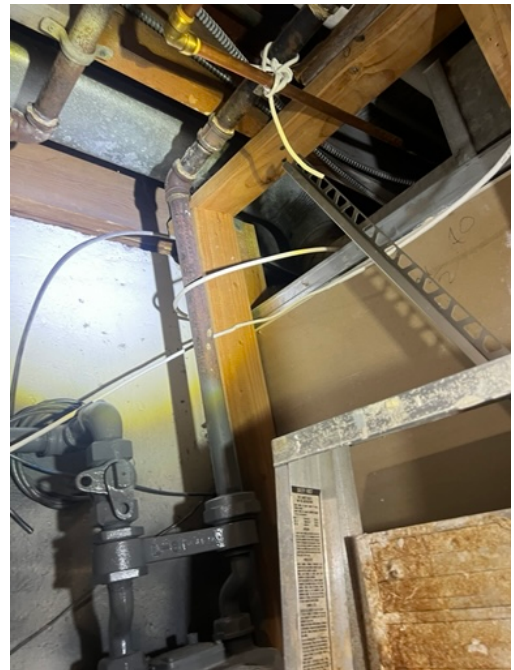
### 12.2) Flooring Support Conditions

Evidence of past leakage was noted in the basement utility room at the time of inspection. Waterproofing or prior repair measures also appear to be present. The area should be monitored and repaired further as needed.
