## Report Summary Page

This is only a summary of the inspection report and is not a complete list of discrepancies.

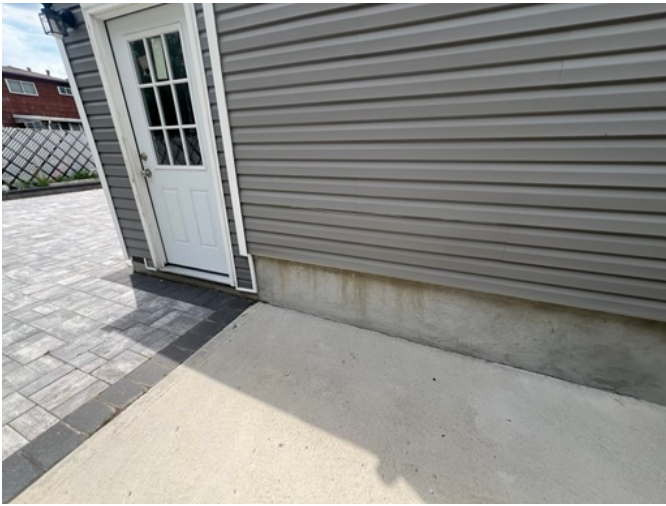
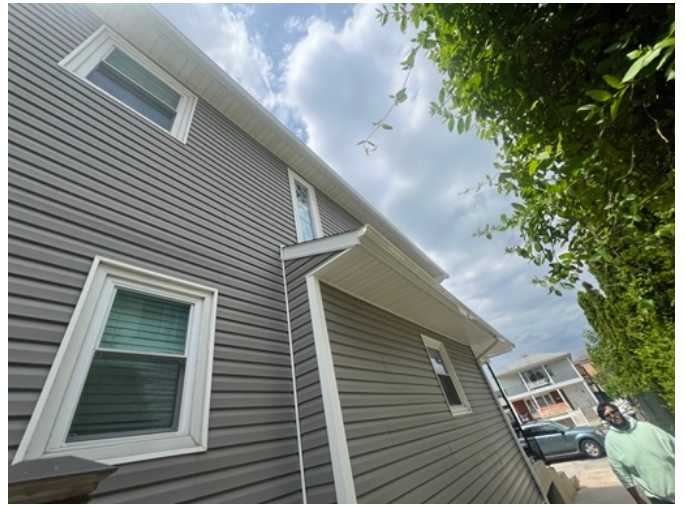
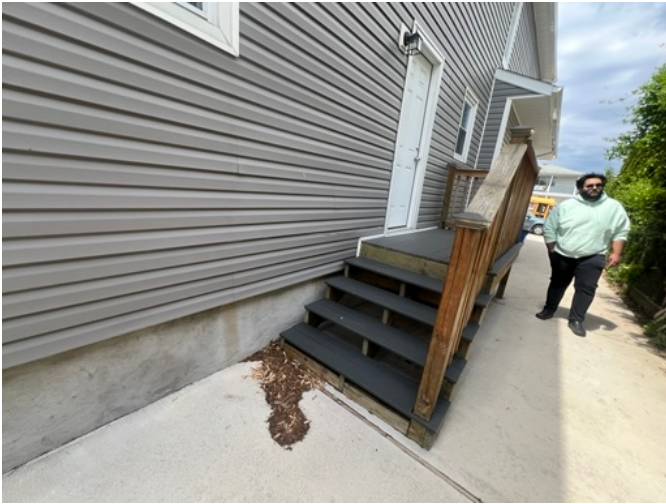
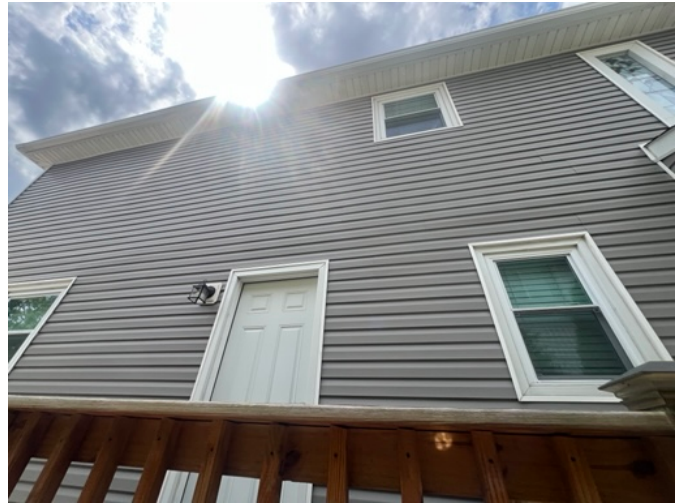
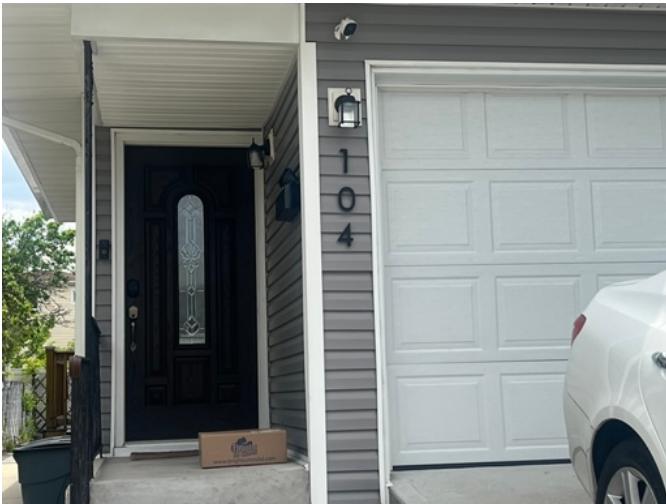
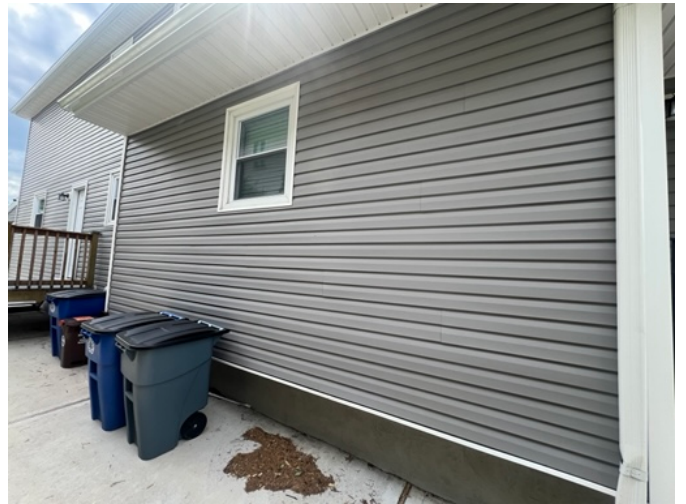
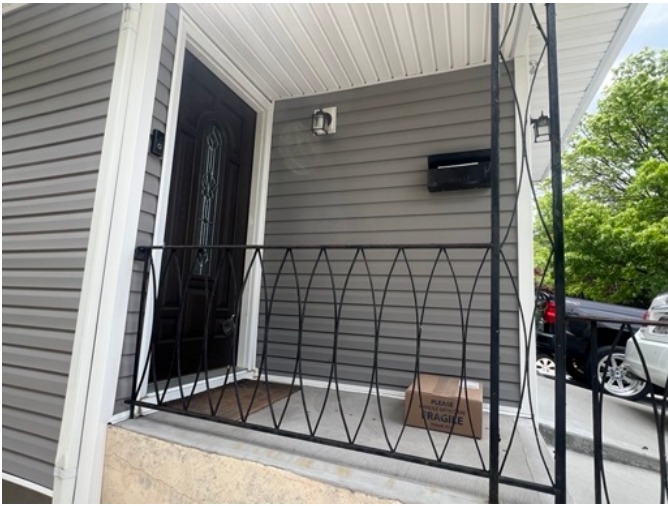
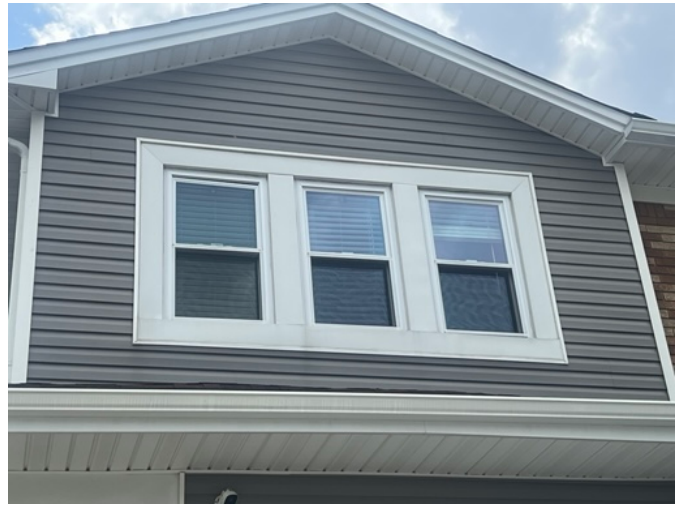
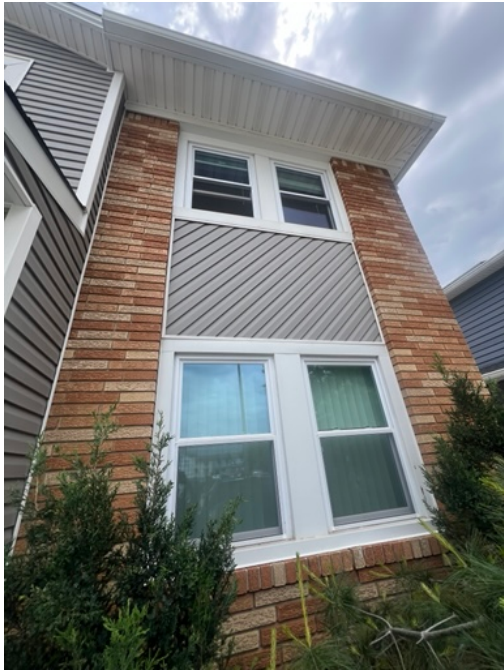
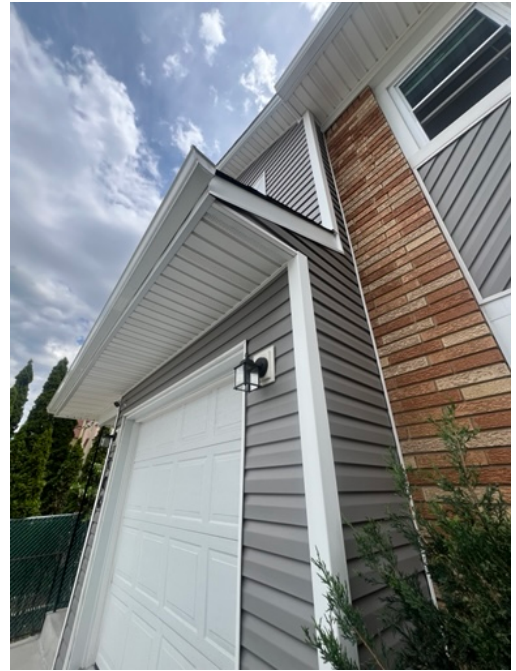
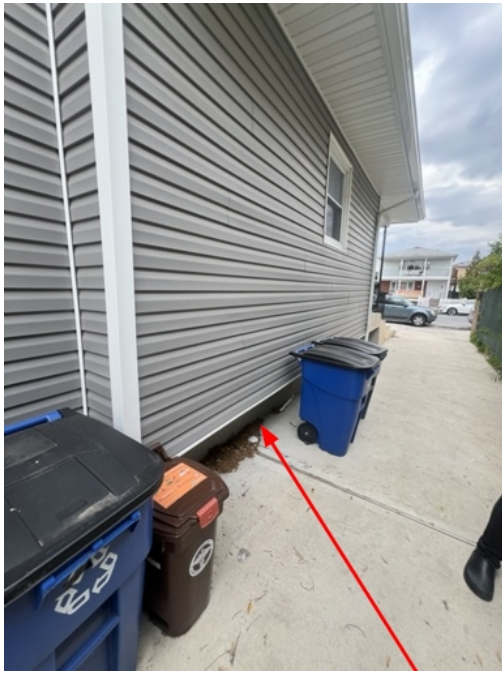
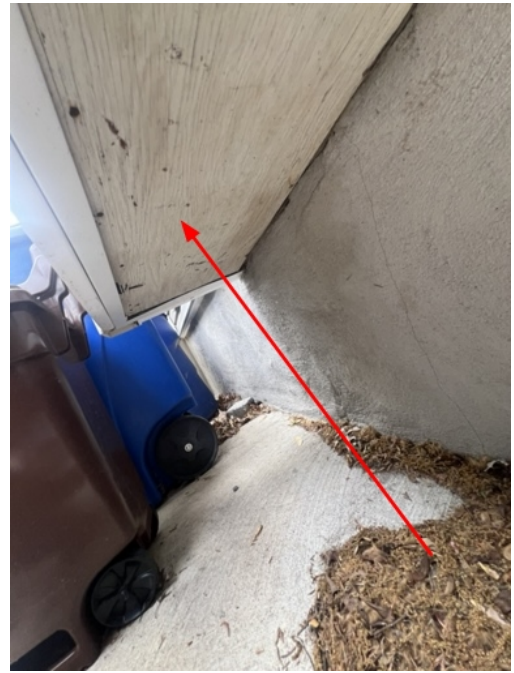
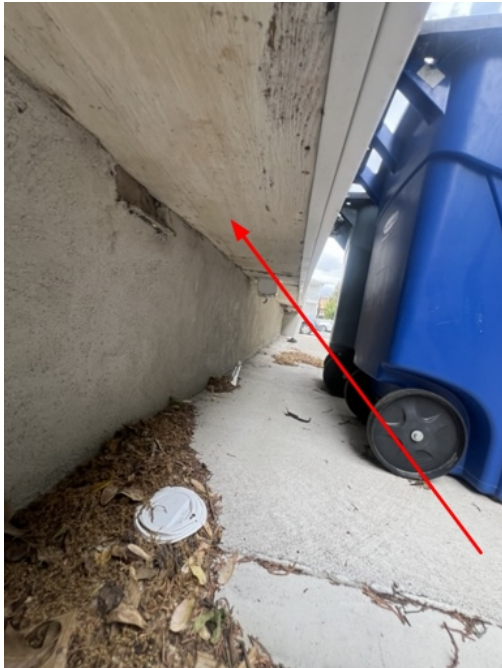
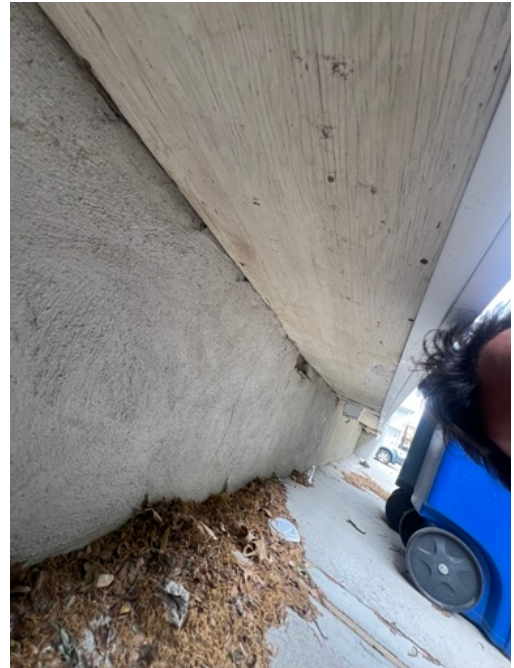
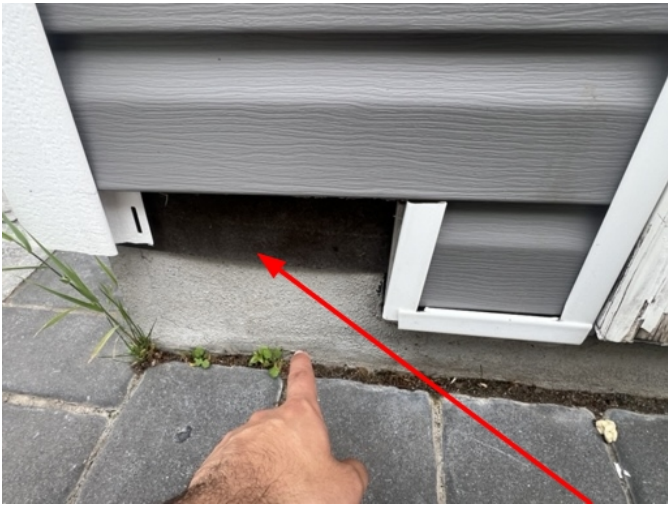
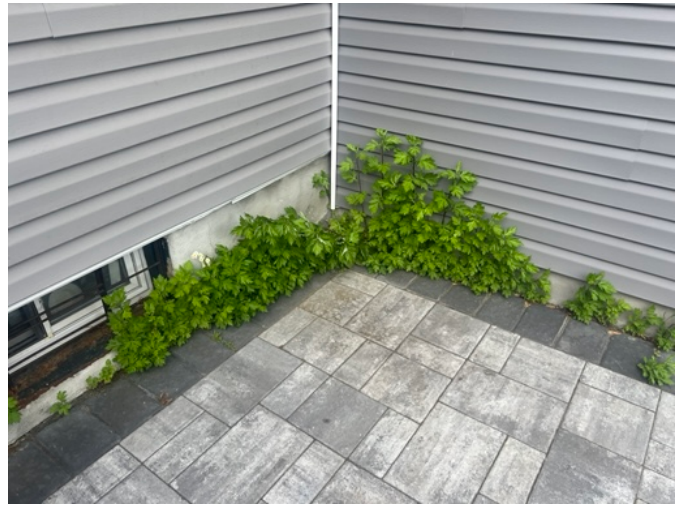
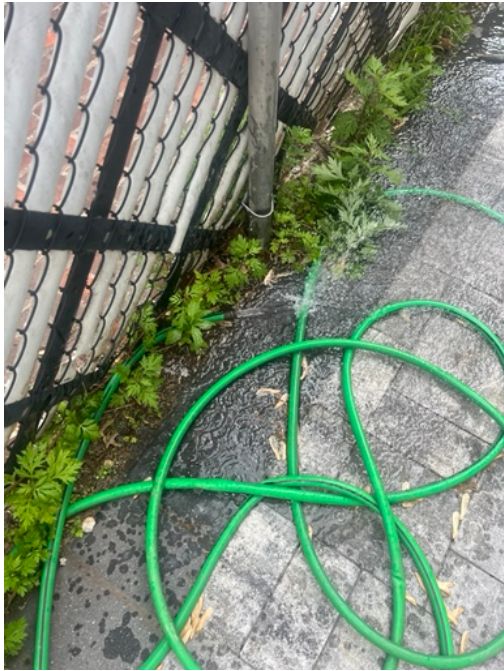
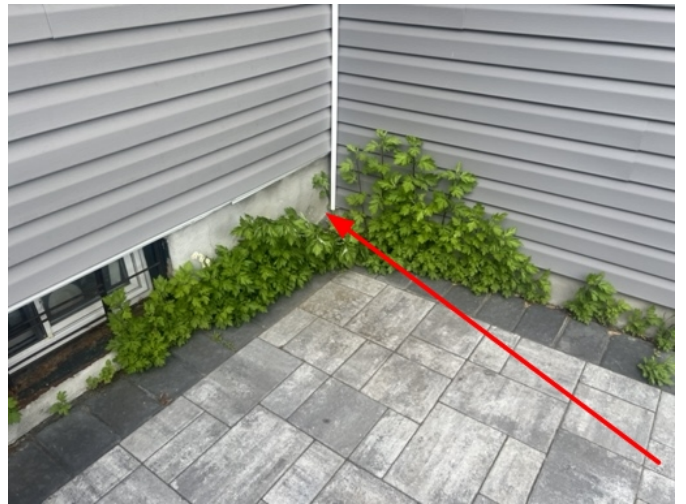
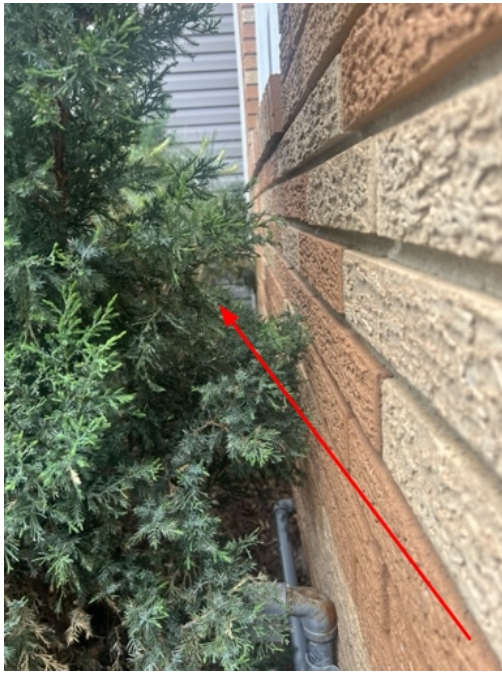
### **2.3 Exterior Wall Conditions (Repair)**

Missing Soffits Underneath Front Porch Area and bump out on east side. Vegetation was in contact with the exterior walls. The vegetation should be trimmed away 1 - 2 feet from the wall. The exterior walls were not fully visible due to overgrown vegetation.

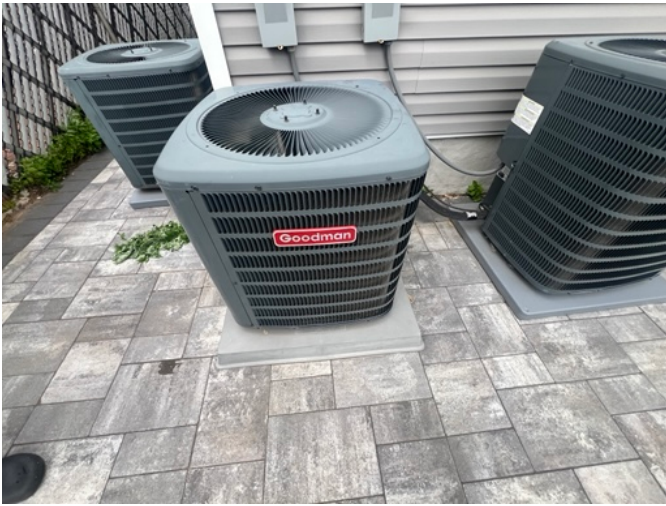
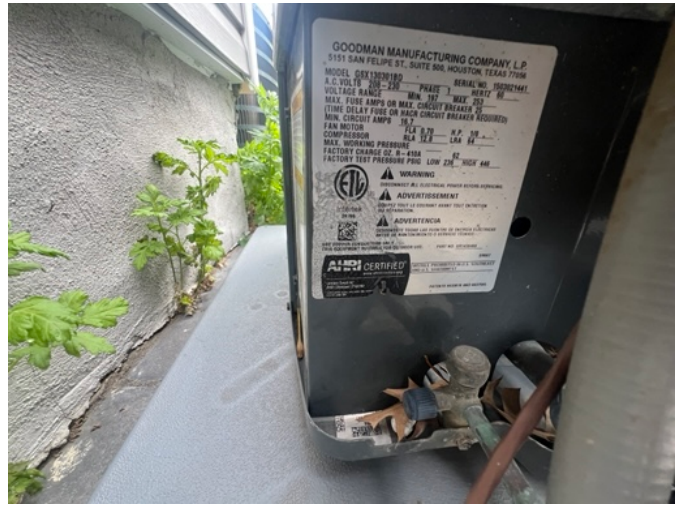
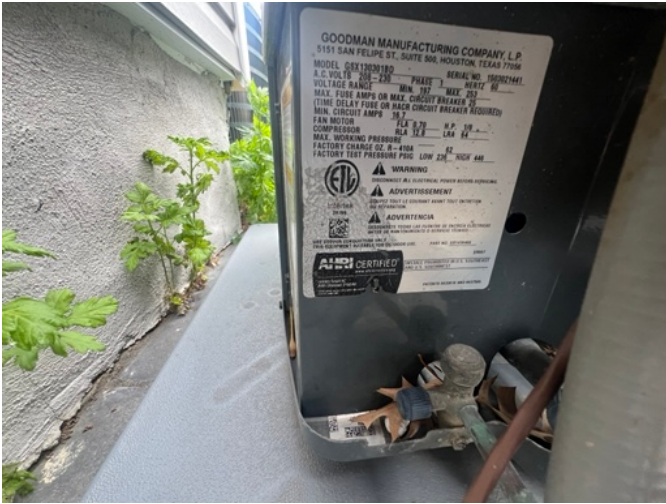
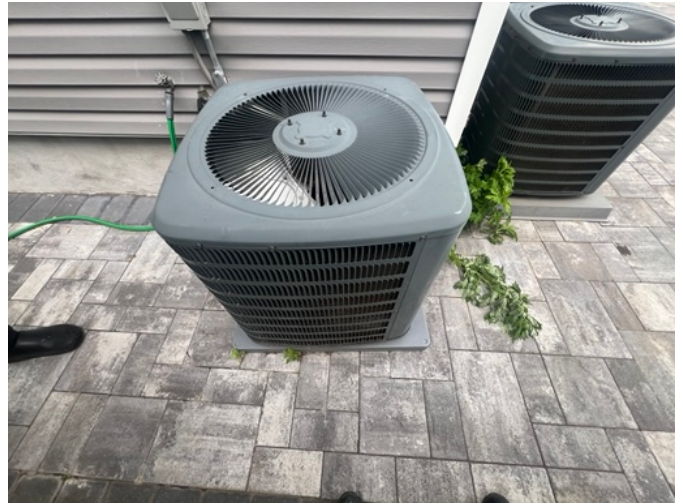
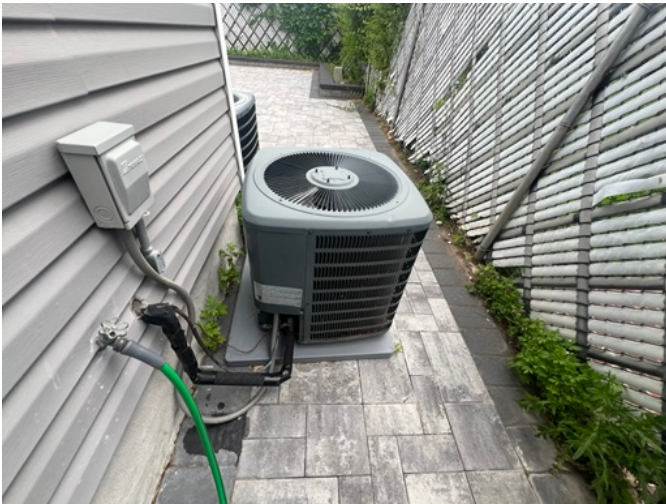
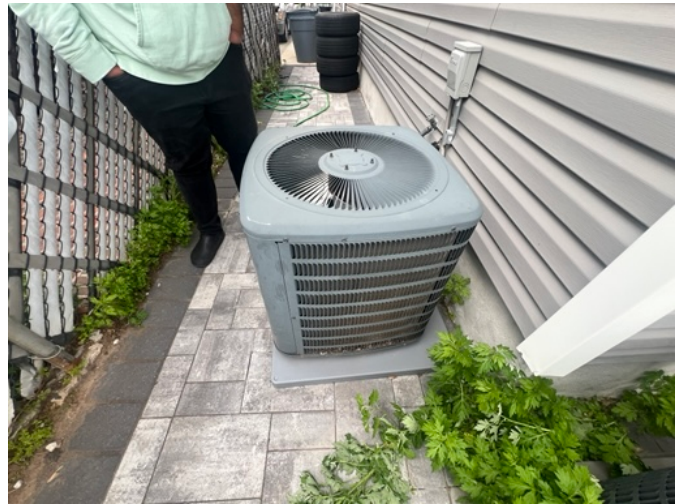
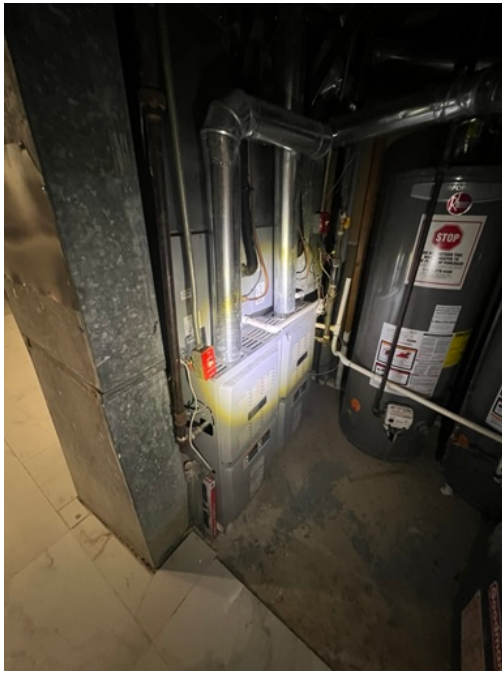
### 4.5 AC Unit Conditions (Repair)

The air handler appears to be from 2015 and was operational at the time of inspection. An unusual noise was noted from the air handler or blower fan during operation. Service and further evaluation by a qualified HVAC contractor is recommended.

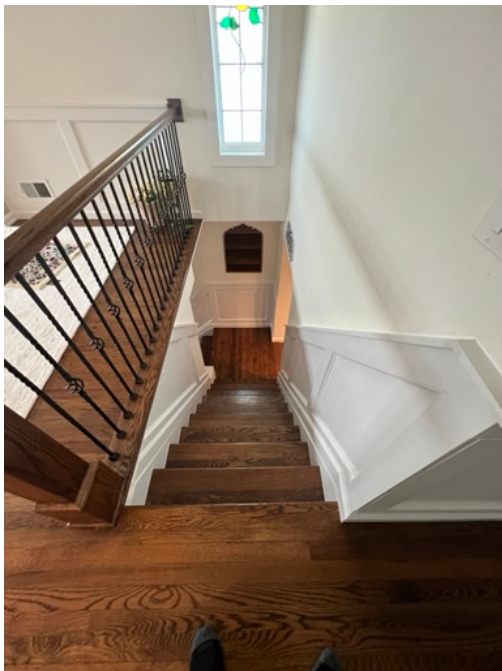
#### **7.5 Railing (Safety)**

A handrail is recommended at the interior wall stair area for improved safety and support. Installation by a qualified contractor is recommended as needed.

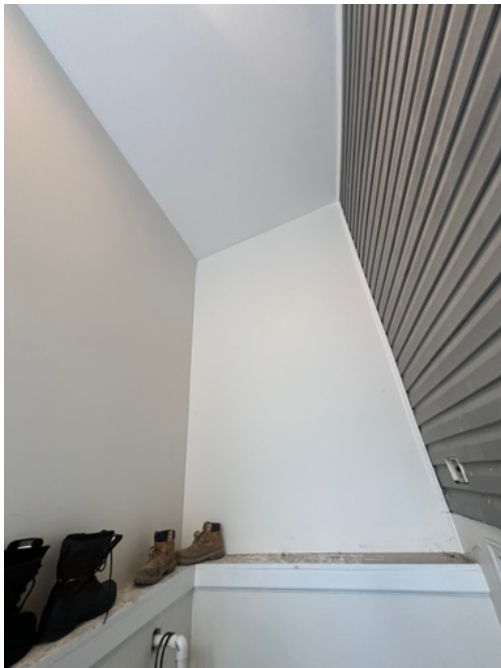
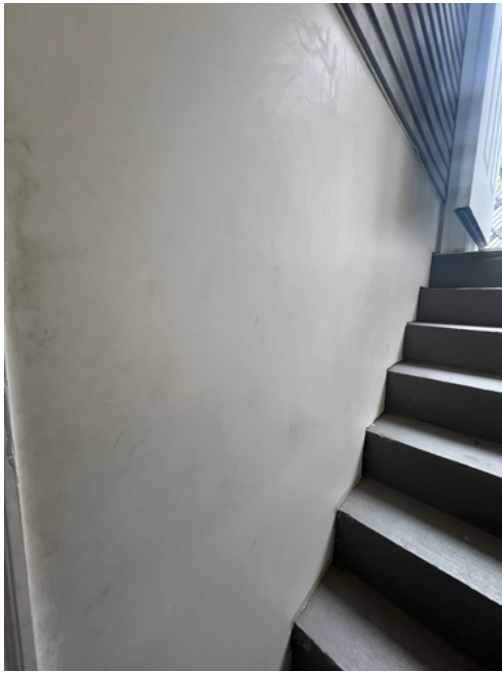
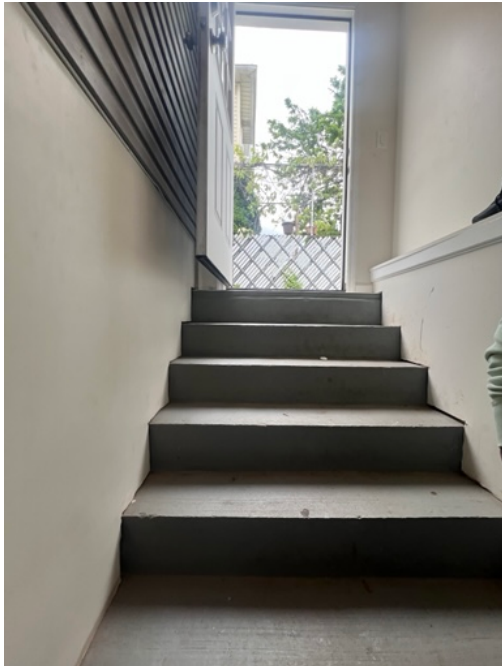
### 10.1 Basement Stair Conditions (Repair)

The stair railing was missing or not installed. Recommend installation of railings as a safety measure.

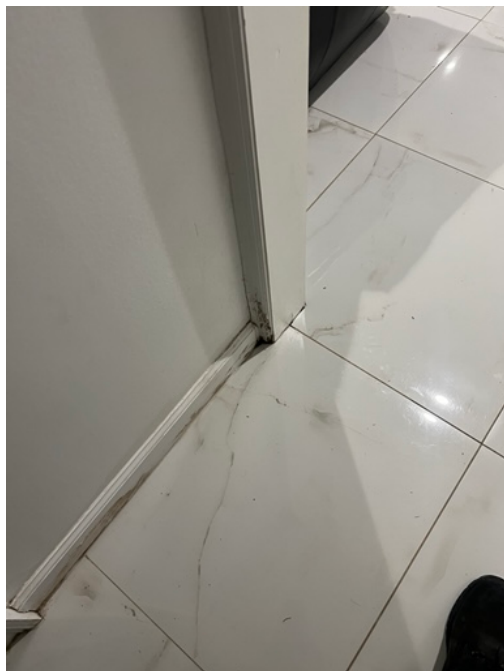
#### **10.11 Other Conditions** (Repair)

Evidence of suspected mold was observed. A mold inspection or testing was not performed as part of this general home inspection. Client is advised to consult a qualified mold testing company prior to closing.

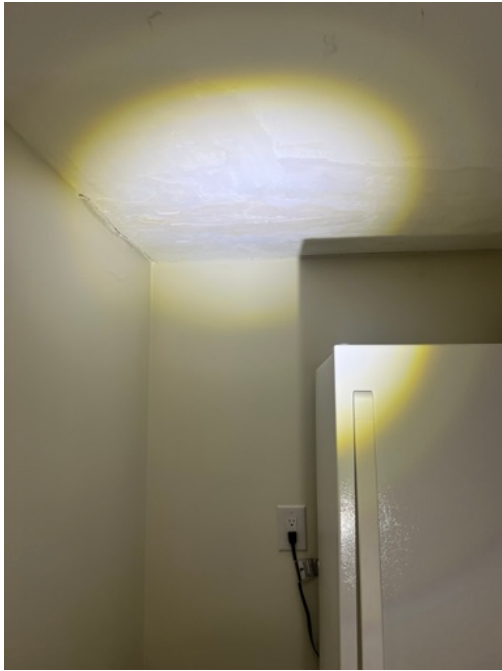
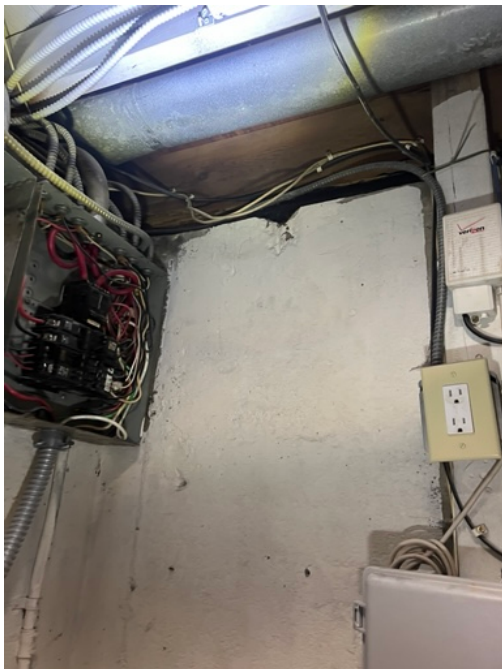
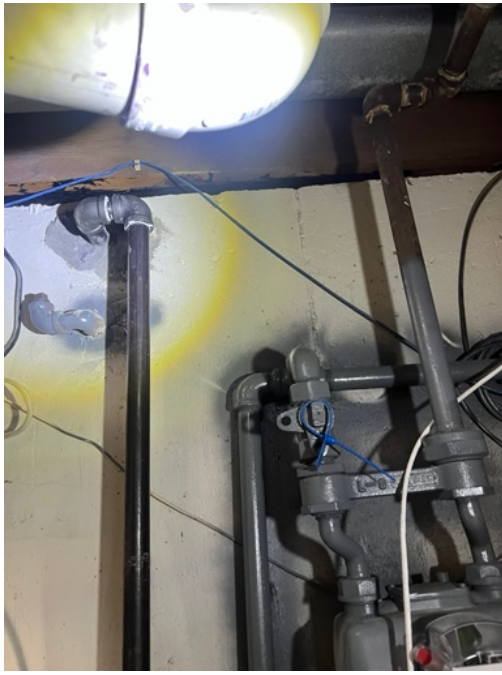
### 12.2 Flooring Support Conditions (Repair)

Evidence of past leakage was noted in the basement utility room at the time of inspection. Waterproofing or prior repair measures also appear to be present. The area should be monitored and repaired further as needed.

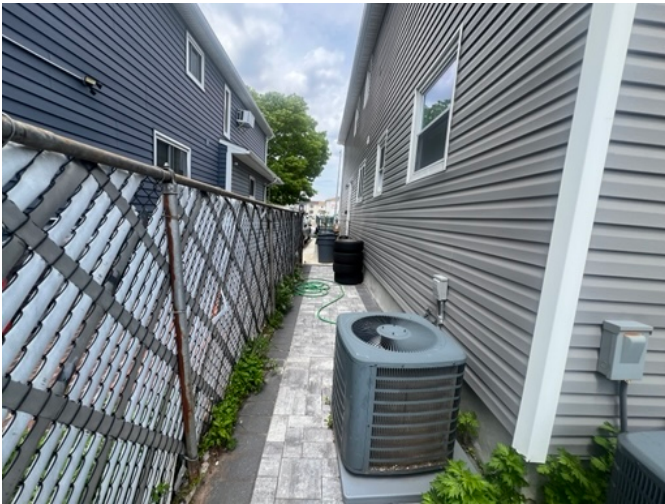
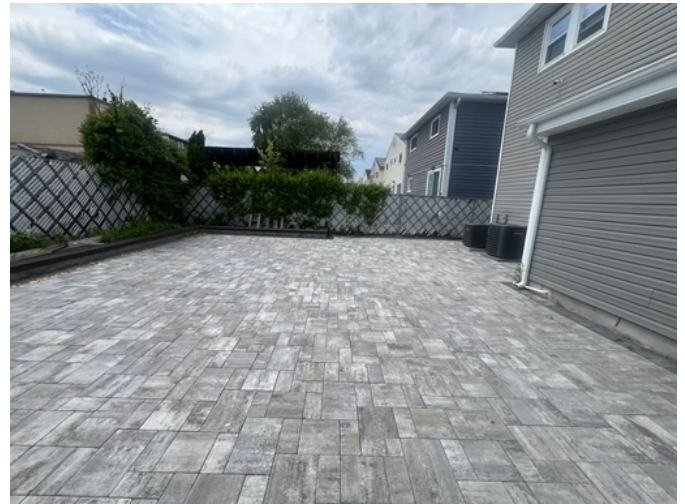
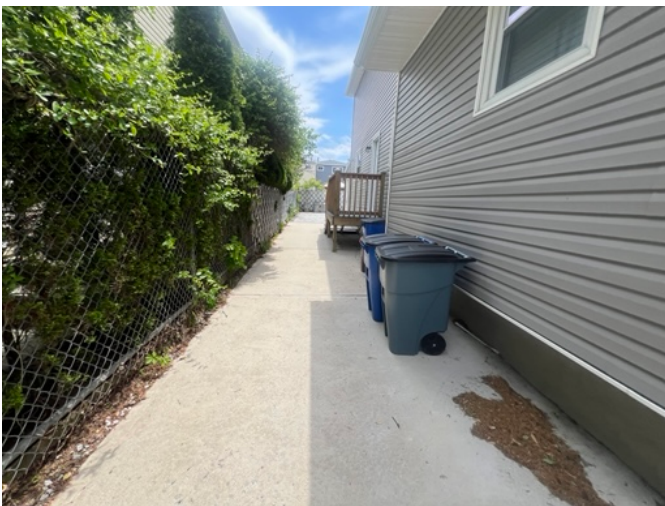
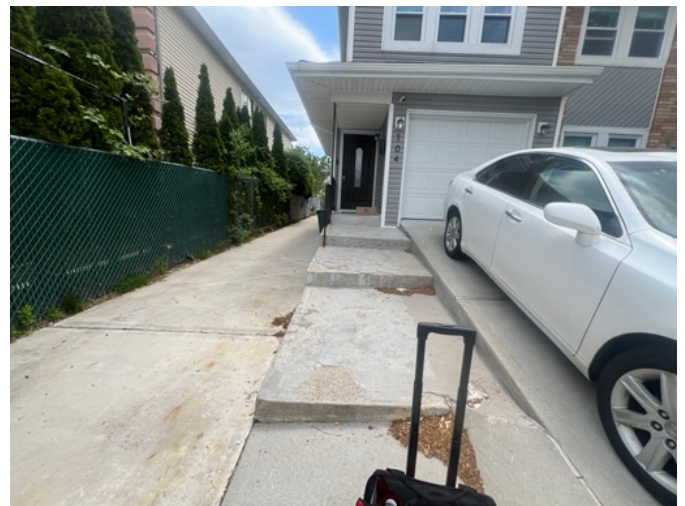
#### 1.1) Grading Conditions

Grading of the soil near the foundation appears to be in serviceable condition.

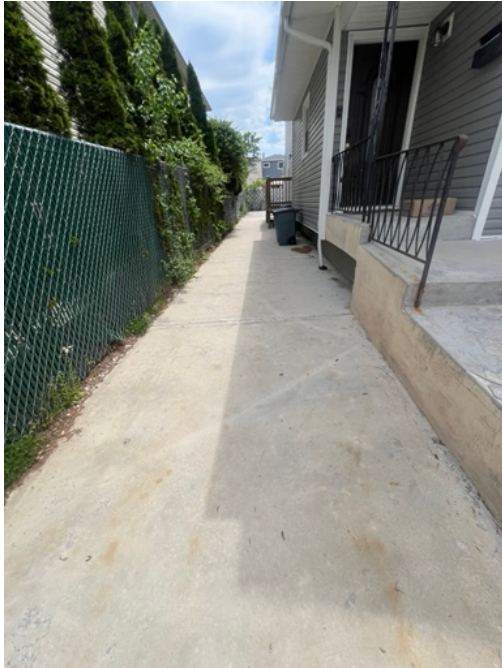
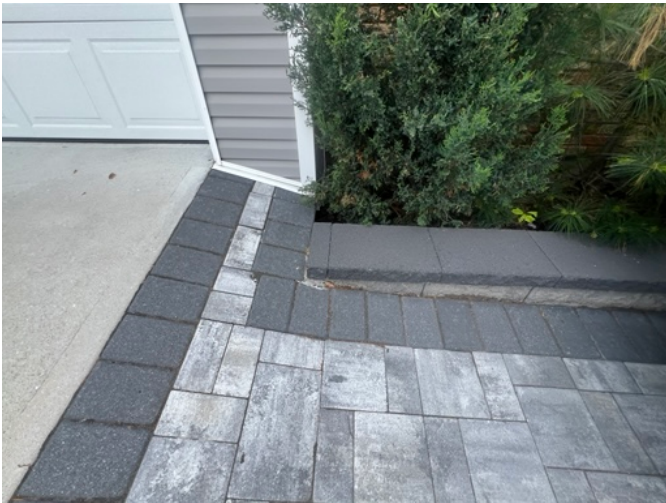
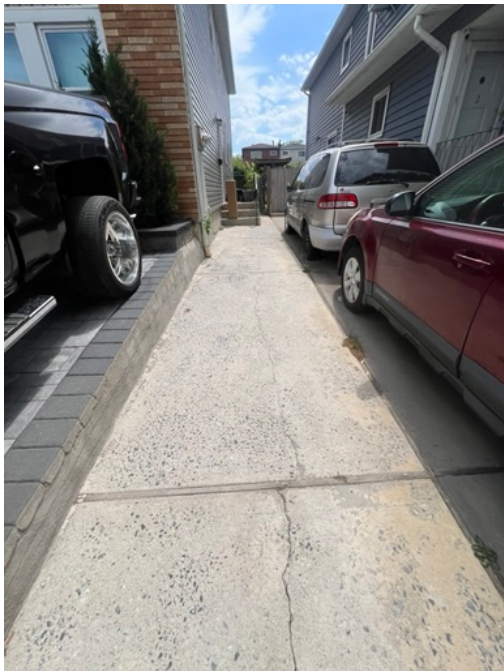
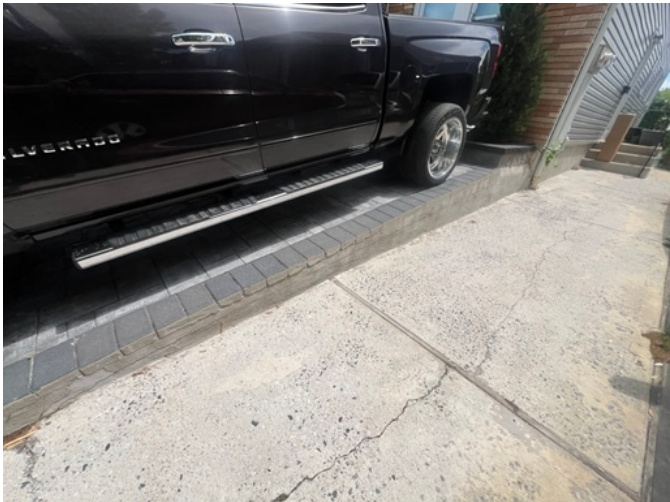
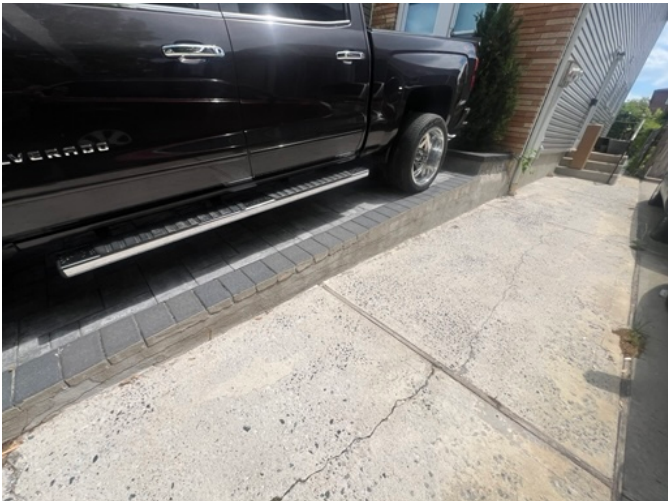
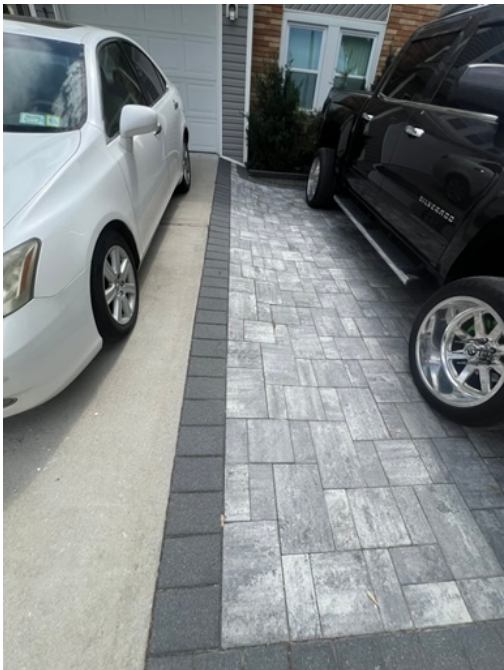
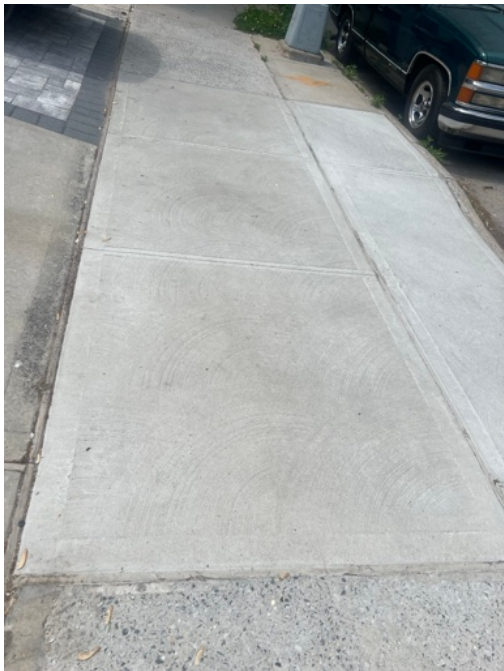
#### 1.2) Driveway Conditions

The driveway has some surface erosion and minor deterioration.

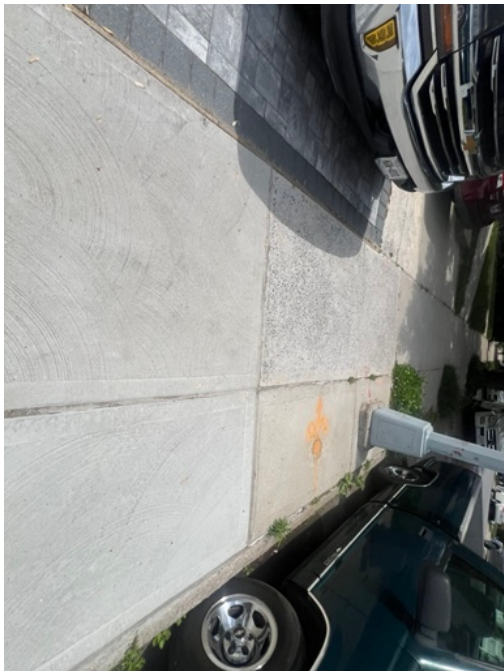
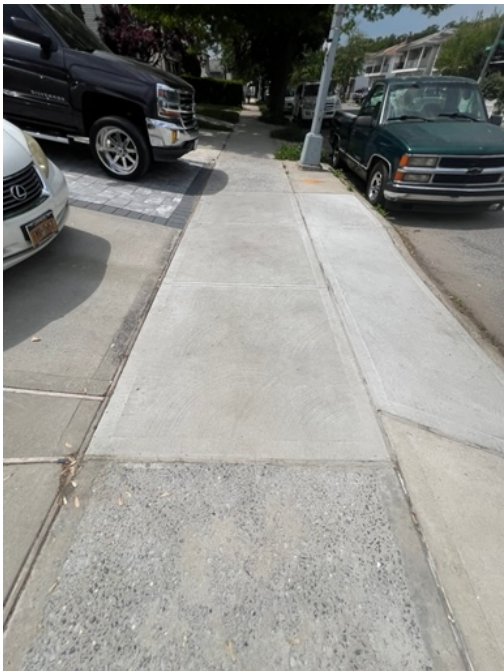
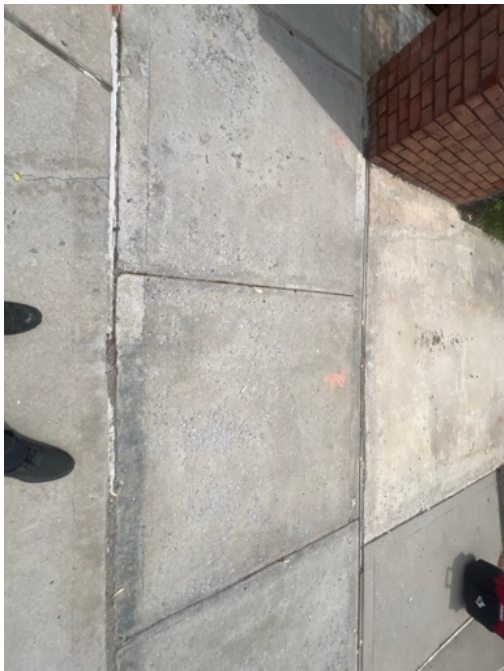
**1.3) Sidewalk Conditions**

The visible areas of the sidewalk appeared to be in serviceable condition at the time of the inspection.

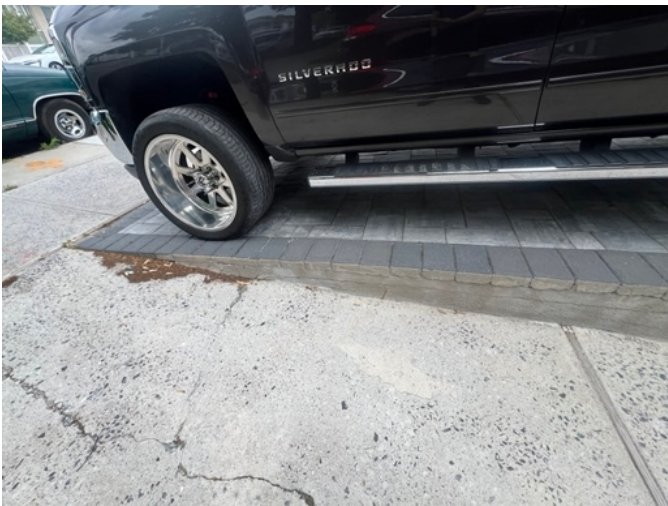
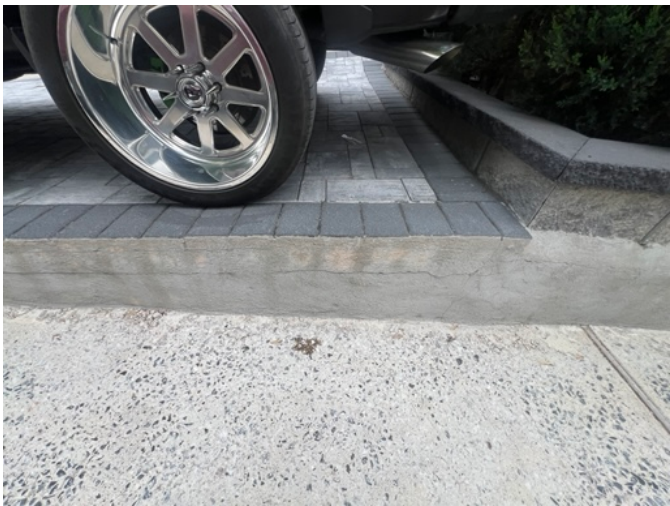
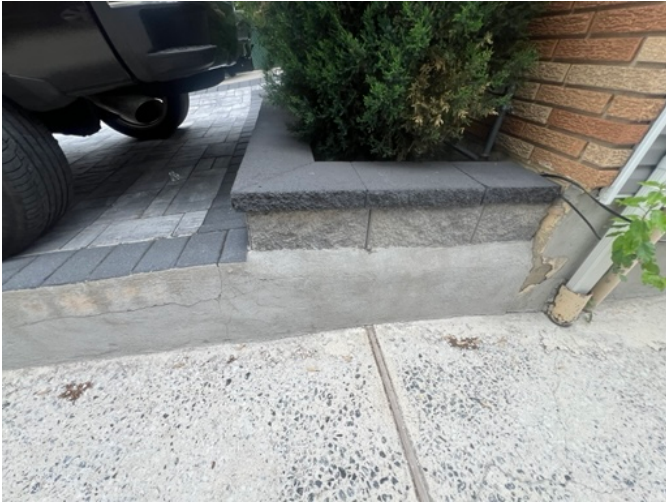
**1.4) Retaining Wall Conditions**     AS

Deterioration and / or damage were observed to the retaining walls.

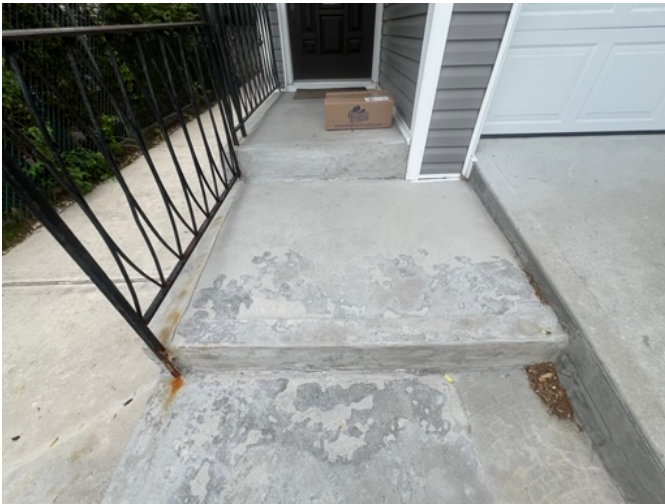
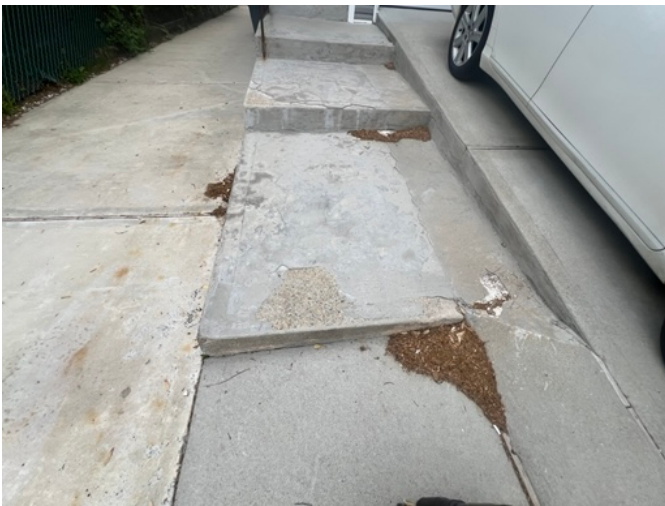
#### 2.1) Front Entrance Conditions

Minor settlement was observed at the porch. Although no immediate concern was observed at the time of inspection, recommend sealing along wall, or any settled areas. Over time, settlement can cause water penetration at the house wall. No railings were present. For increased safety, client should consider installation of a railing. Client should consult with a qualified contractor for information on current standards.

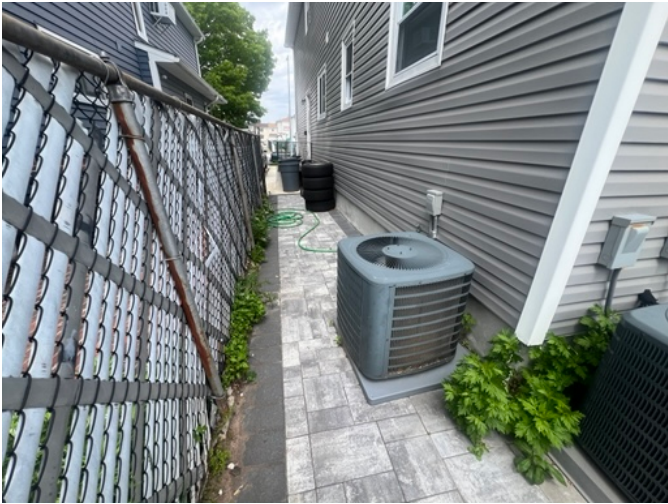
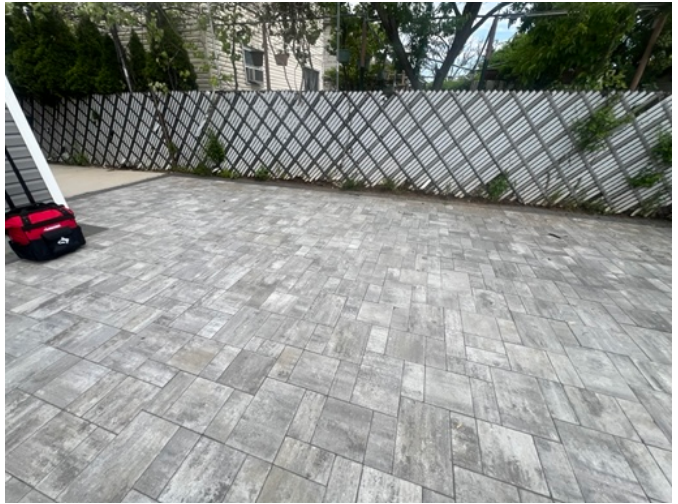
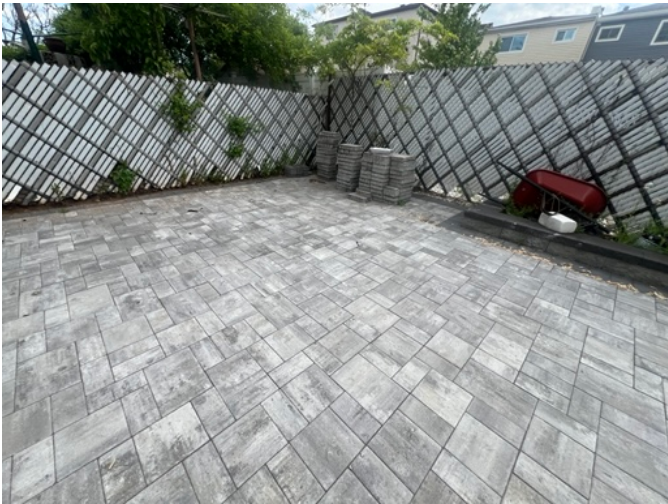
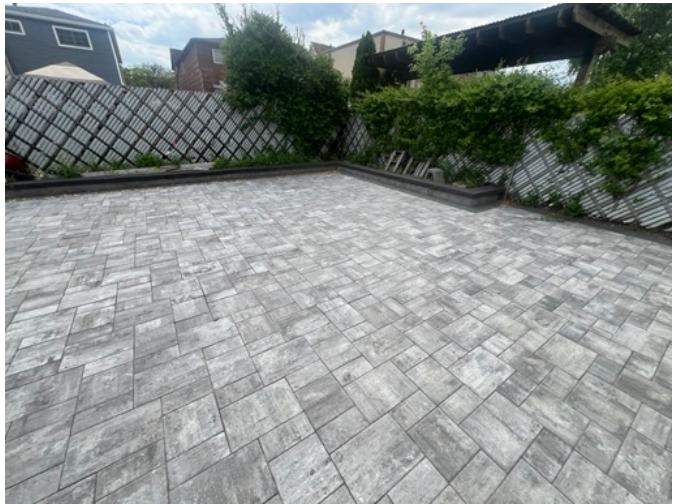
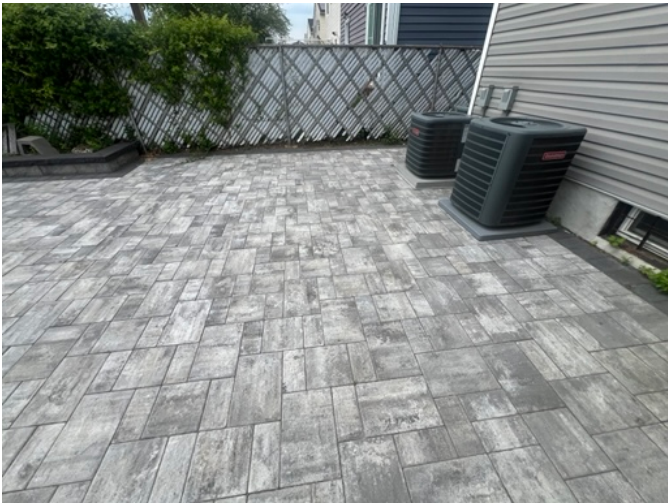
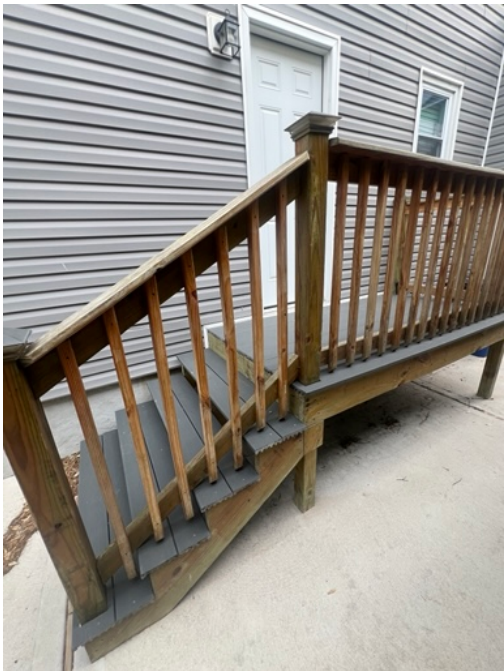
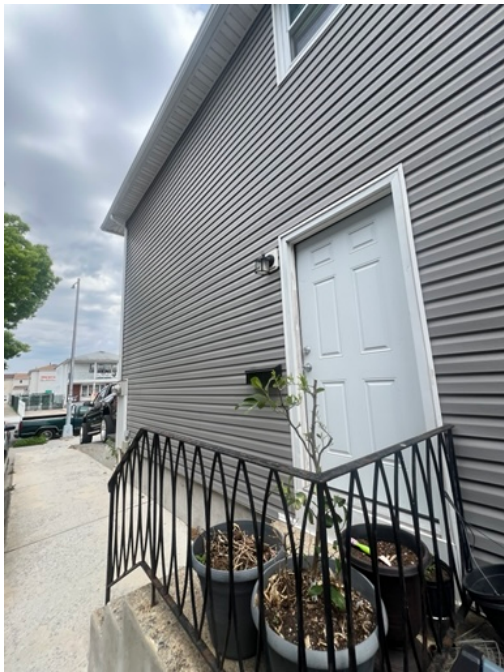
2.2) Back Entrance Conditions

The visible and accessible areas of the porch appeared to be in serviceable condition at the time of the inspection.

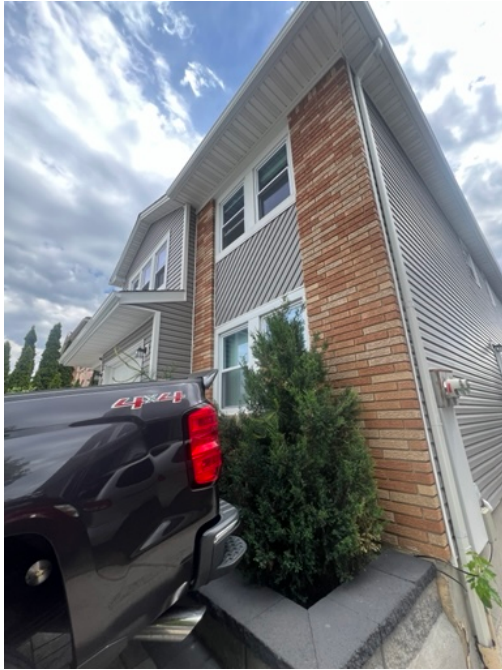
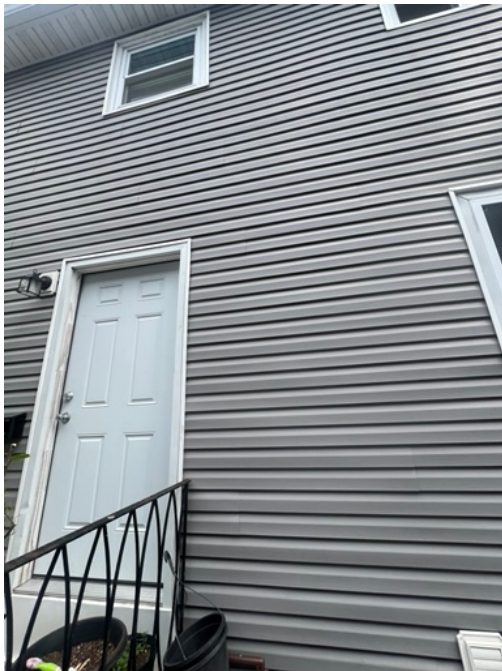
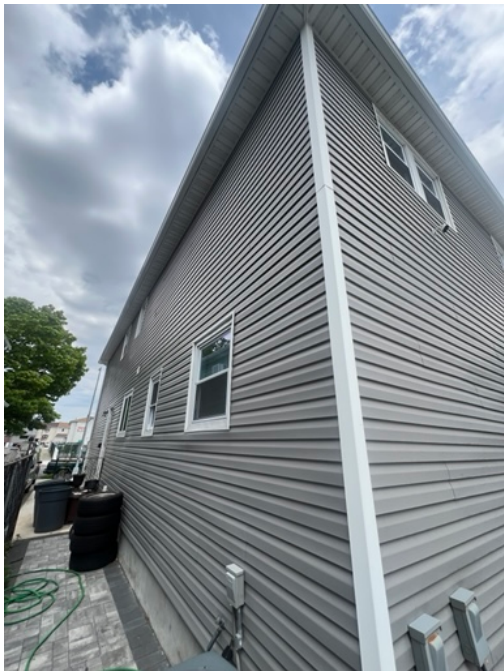
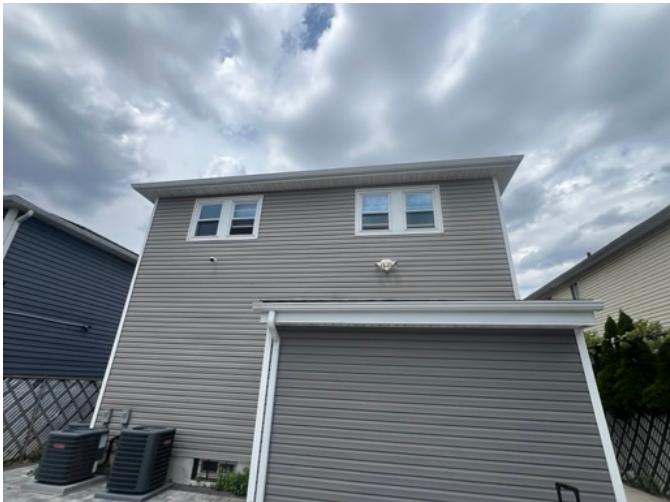
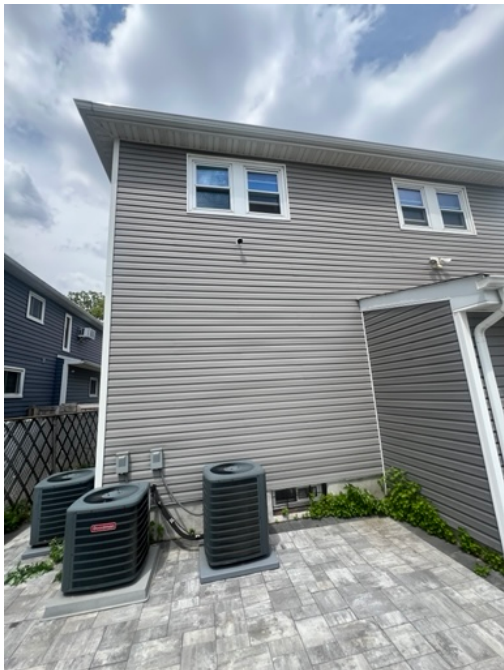
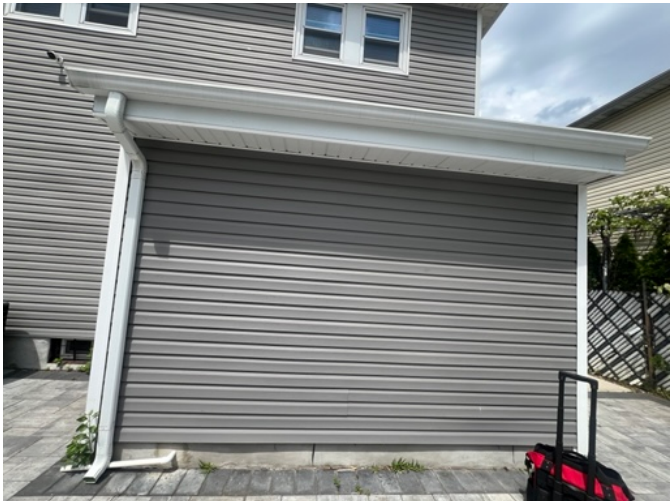
2.3) Exterior Wall Conditions

Missing Soffits Underneath Front Porch Area and bump out on east side. Vegetation was in

contact with the exterior walls. The vegetation should be trimmed away 1 - 2 feet from the wall. The exterior walls were not fully visible due to overgrown vegetation.
