## Report Summary Page

This is only a summary of the inspection report and is not a complete list of discrepancies.

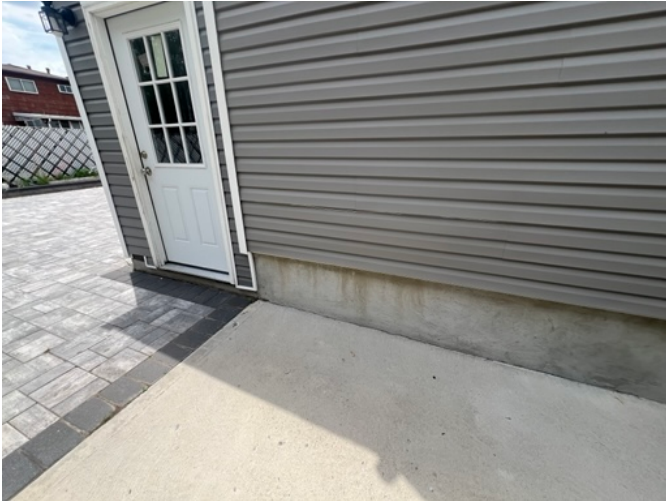
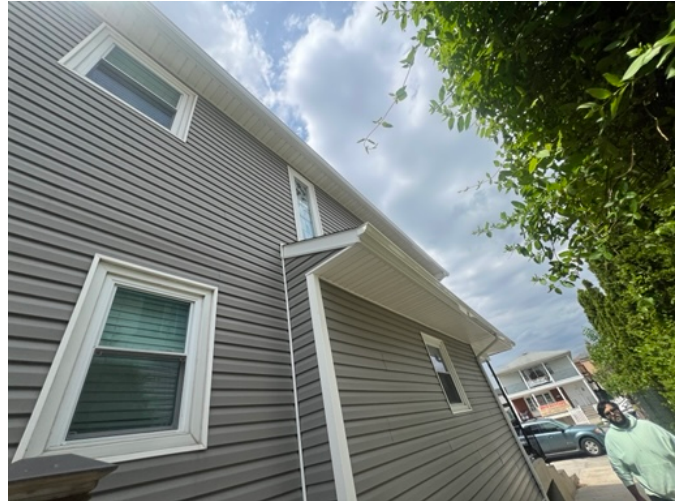
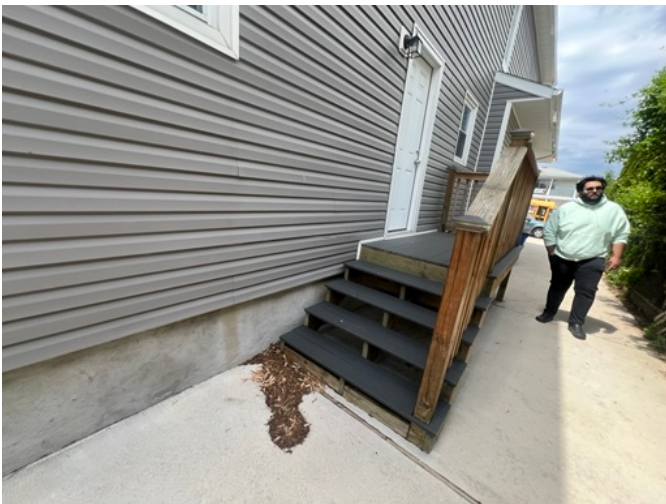
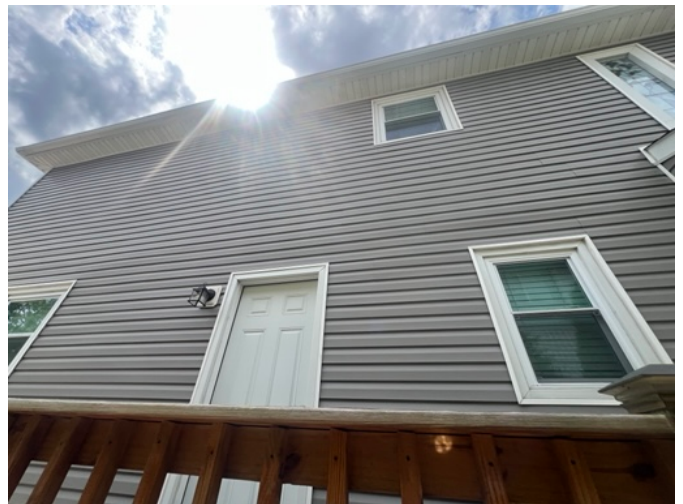
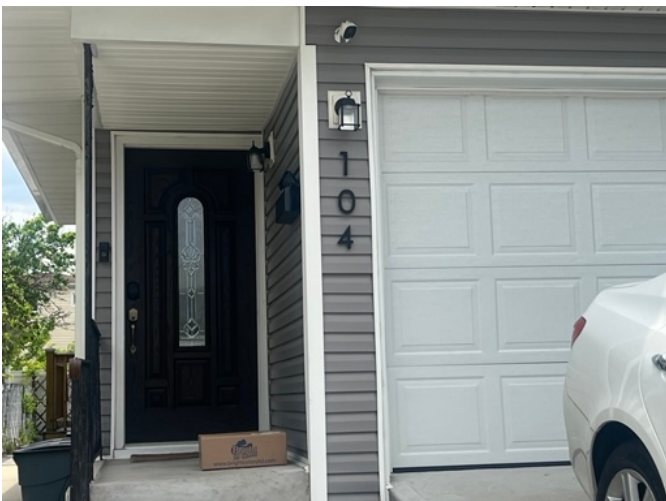
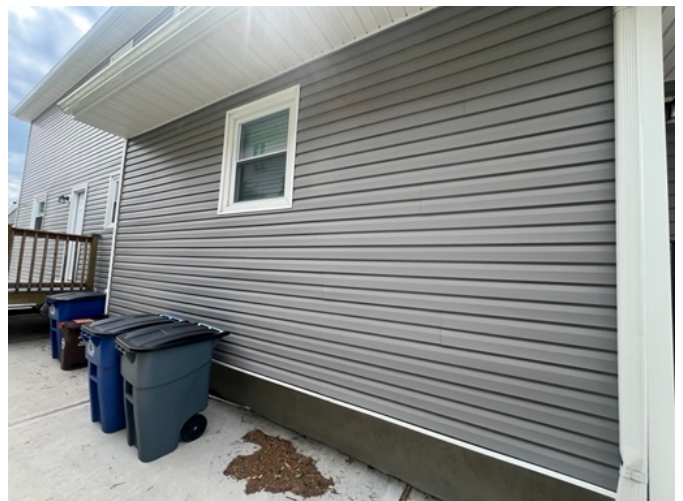
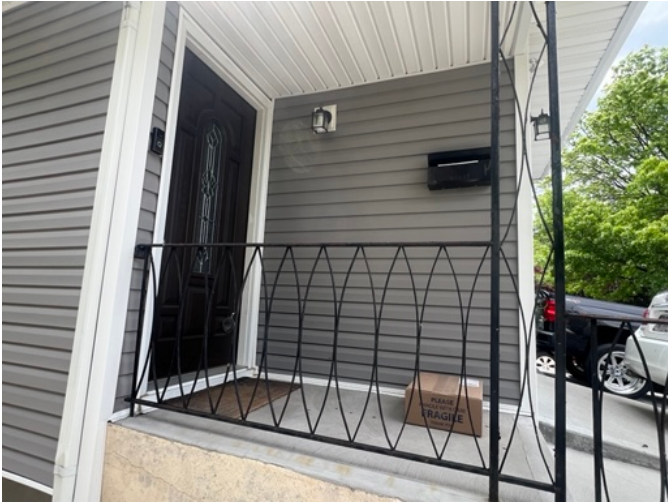
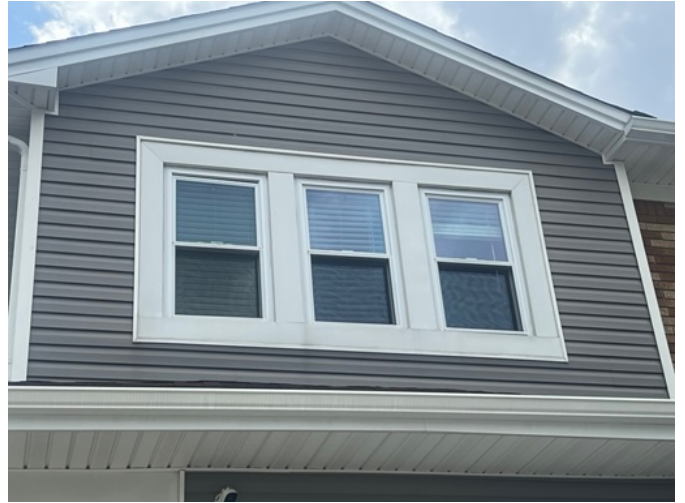
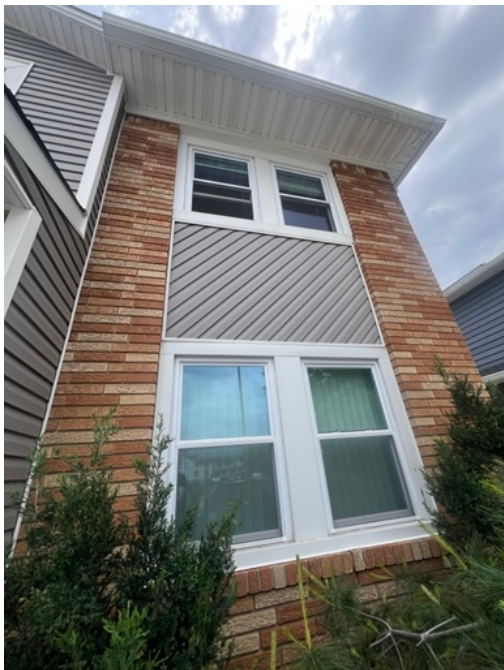
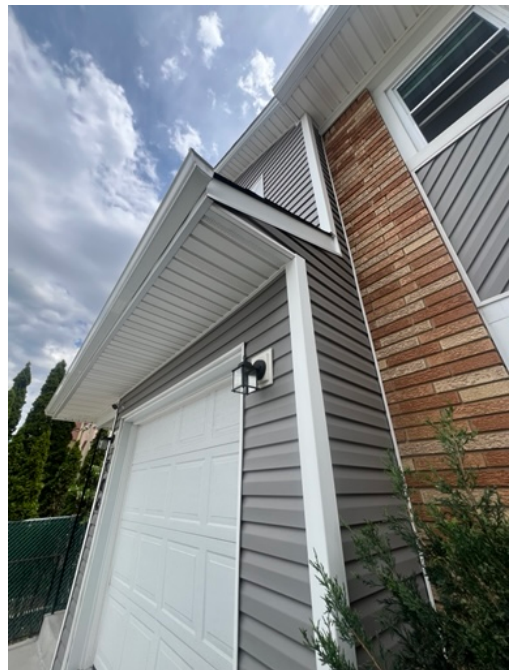
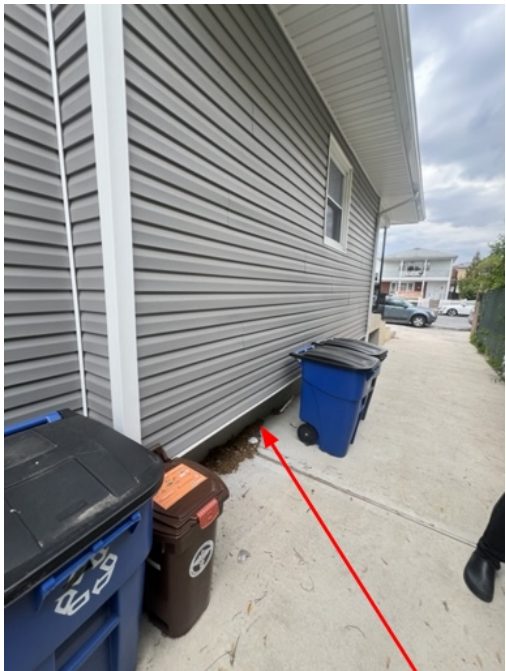
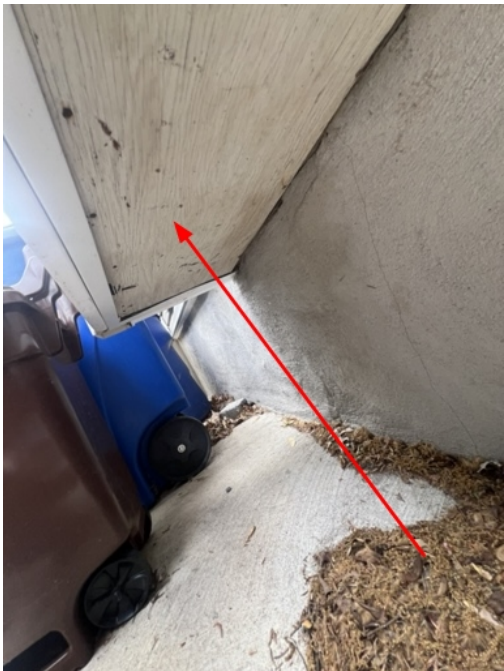
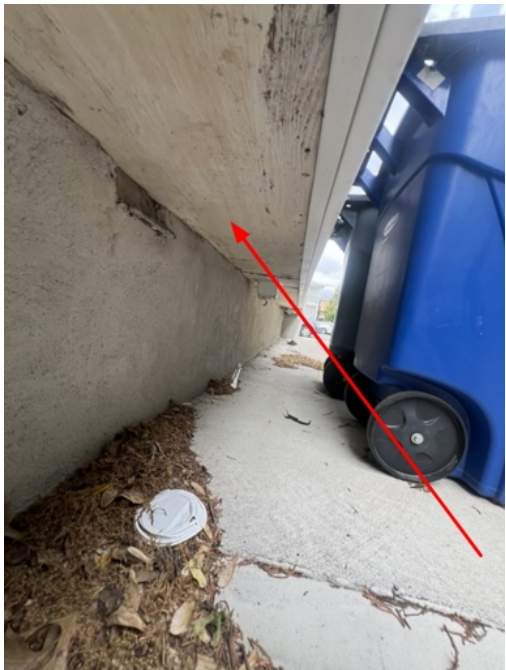
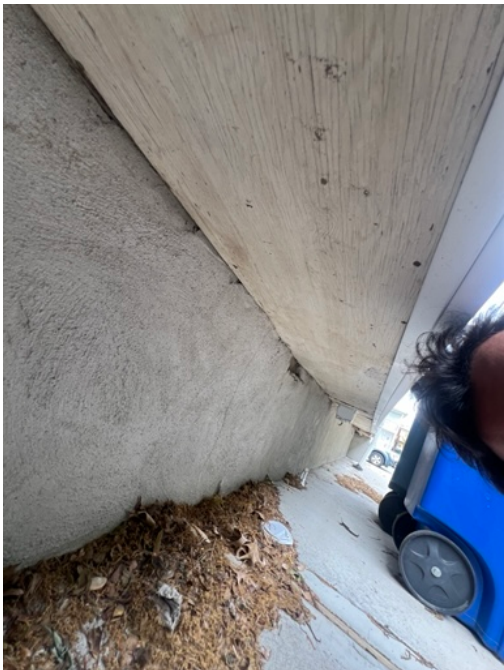
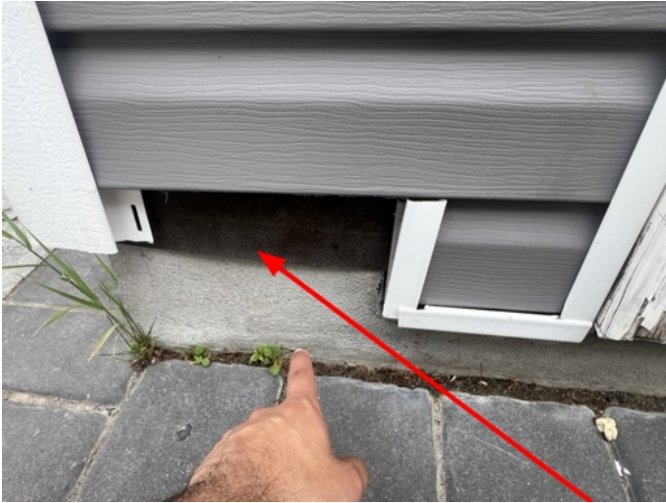
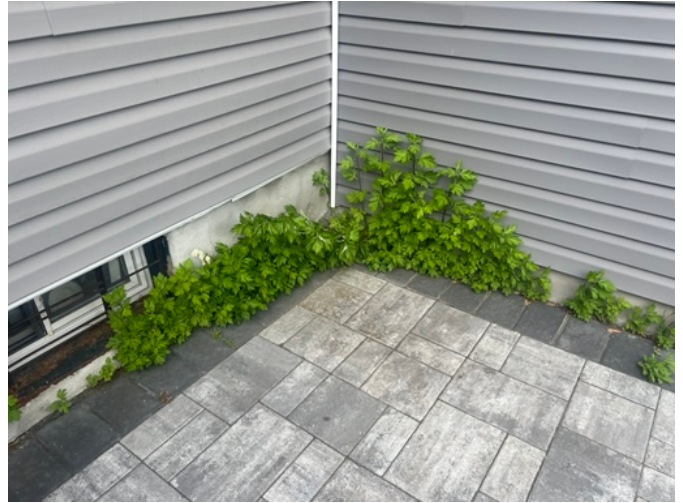
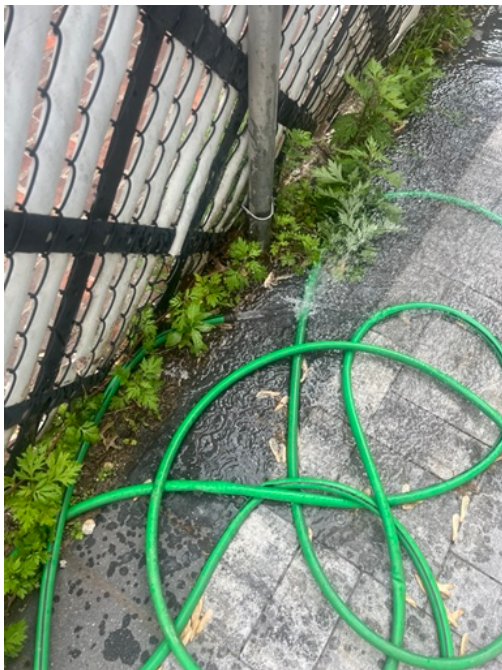
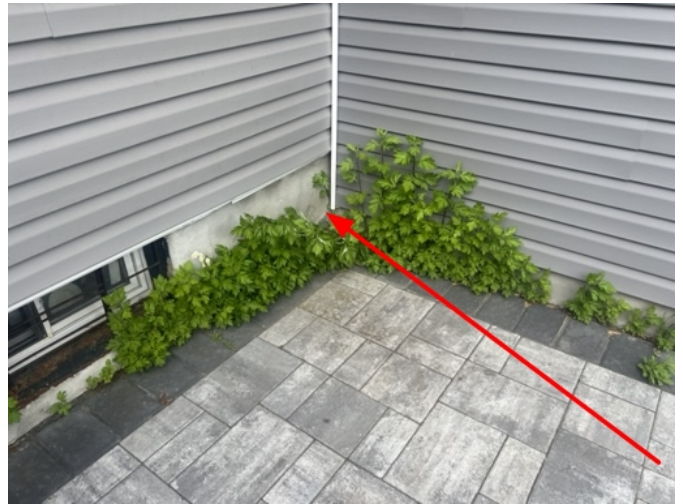
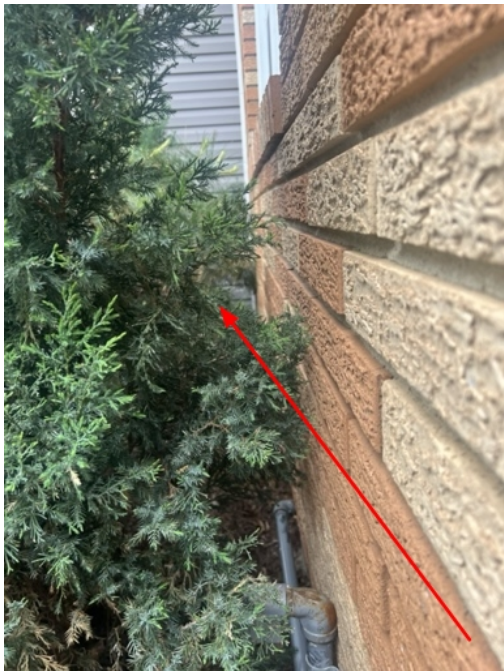
2.3) Exterior Wall Conditions

Missing Soffits Underneath Front Porch Area and bump out on east side. Vegetation was in contact with the exterior walls. The vegetation should be trimmed away 1 - 2 feet from the wall. The exterior walls were not fully visible due to overgrown vegetation.

Missing Soffits Underneath Front Porch Area and bump out on east side. Vegetation was in

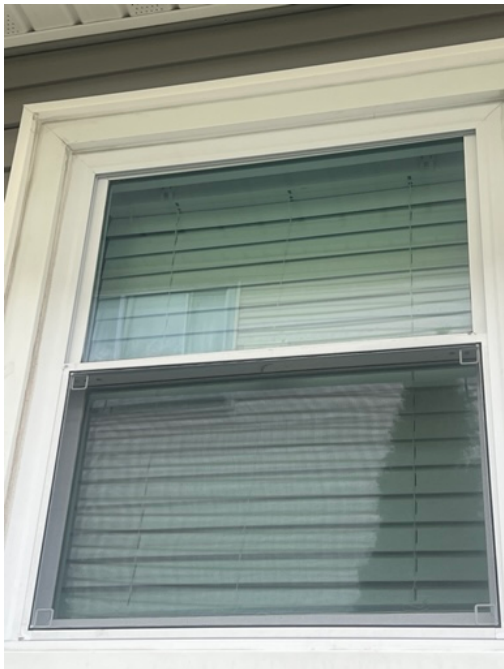
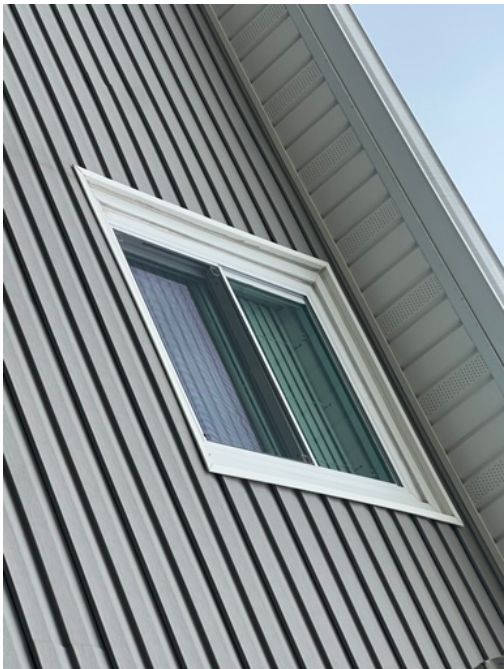
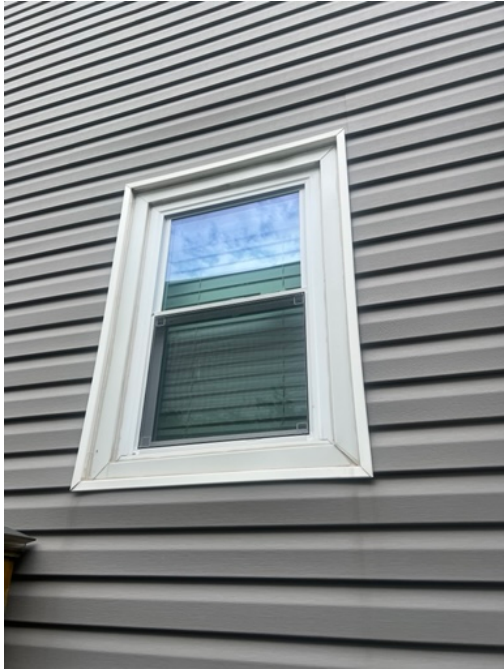
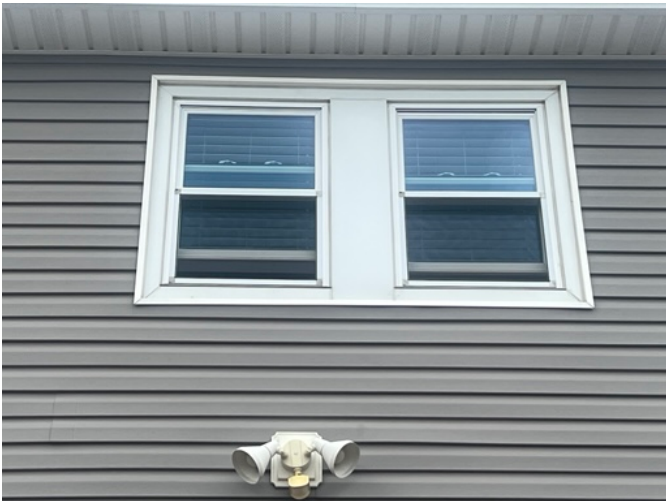
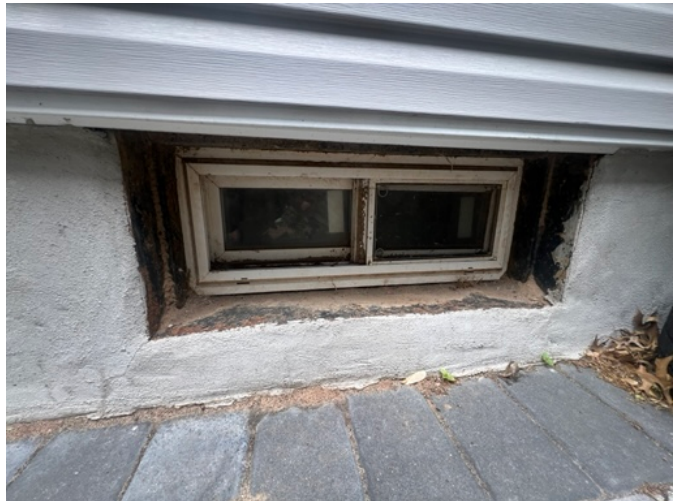
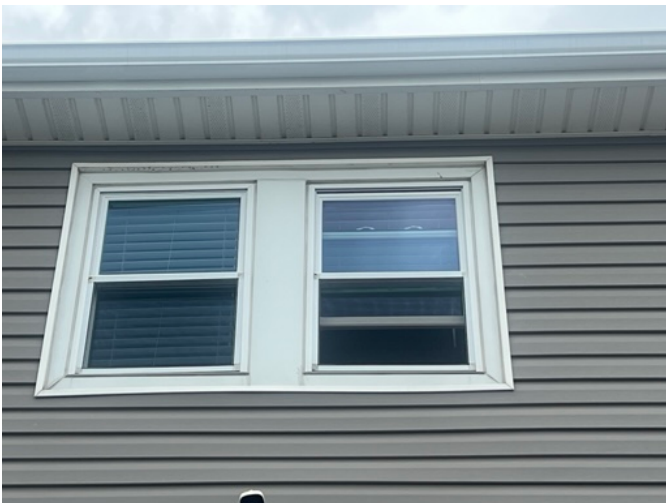
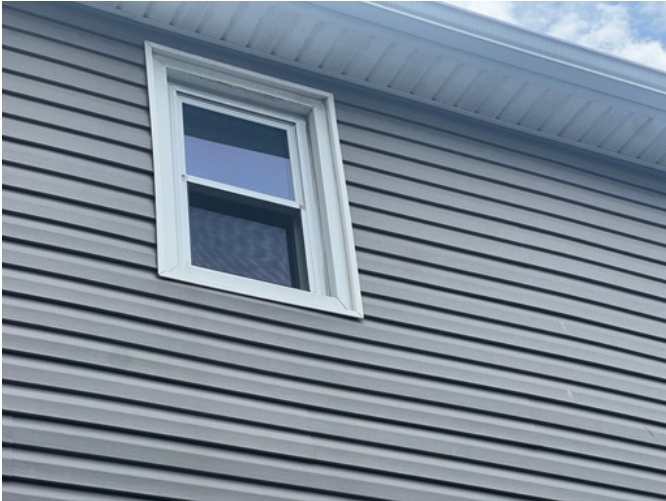
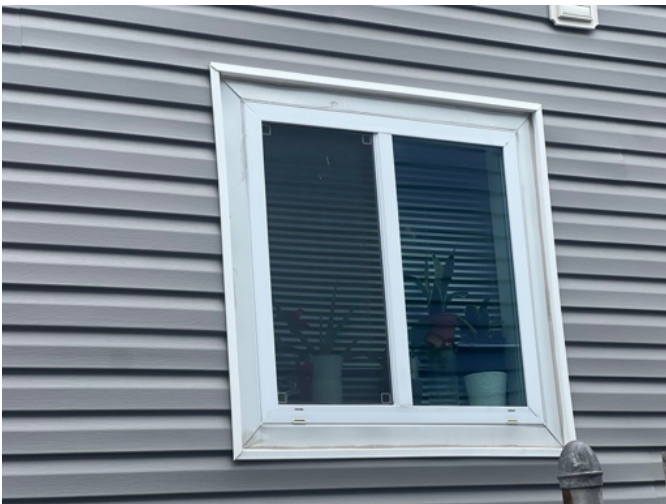
**2.4) Window Conditions**      AS

Exterior frame weathering and some deterioration was observed on basement windows.  
Remaining Windows Appears Serviceable.

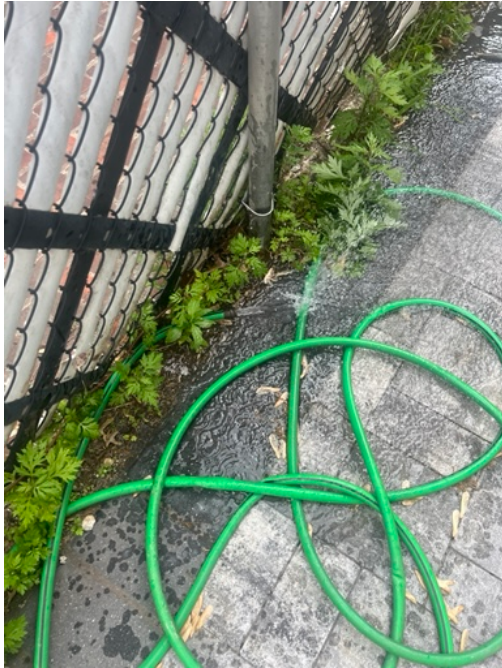
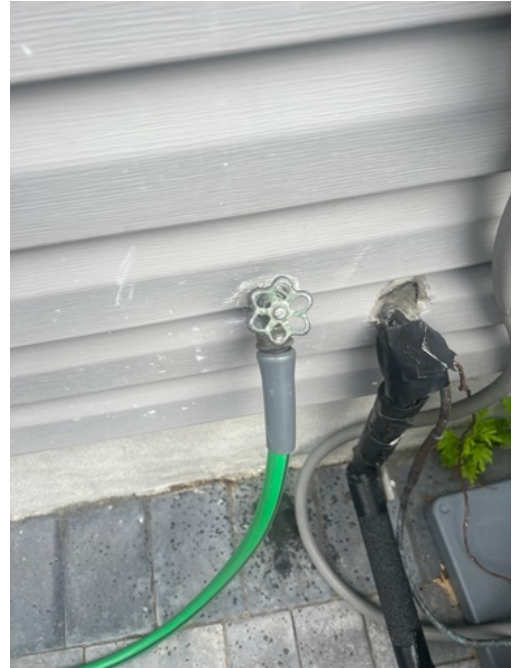
### 2.6) Faucet Conditions

The hose faucets appeared to be in serviceable condition at the time of the inspection. These should be drained prior to freezing temperatures.

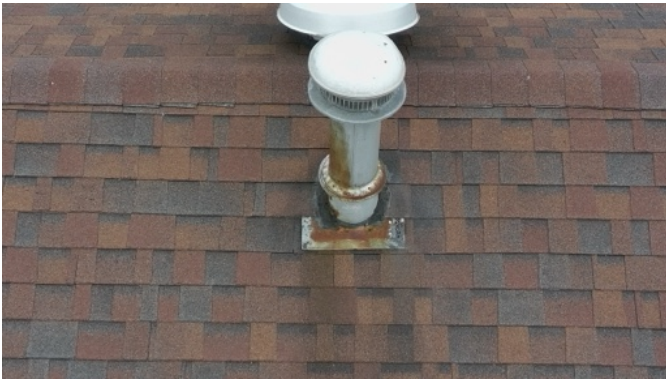
### 2.7) Chimney Conditions

The pre-fabricated flue and / or cap was rusted.

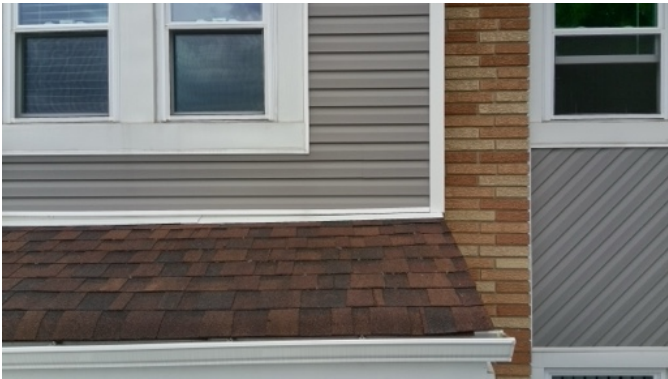
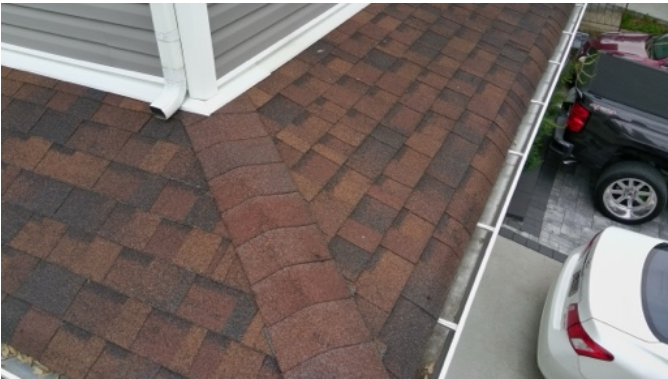
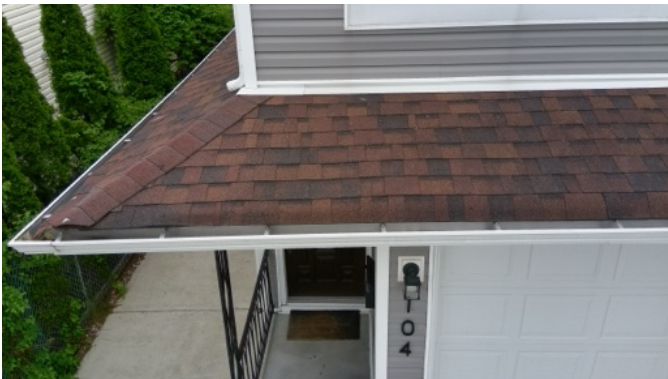
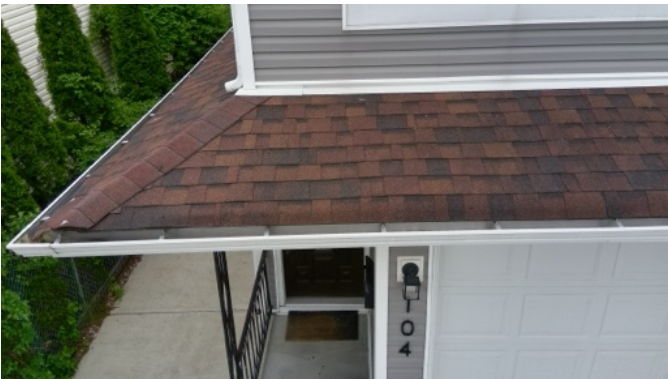
3.1) Roof Covering Condition

The other roof appeared generally serviceable at the time of inspection. However, like any roofing system, its longevity depends on proper maintenance and regular inspections. To help prolong the lifespan of the roof, it is recommended to conduct yearly inspections and perform routine maintenance, such as checking for damaged shingles, sealing flashing, and clearing debris from gutters and drainage areas. This proactive approach can help identify minor issues before they become significant problems. However, it is important to note that this is not a guarantee of future conditions, as weather exposure, natural aging, and unforeseen factors can impact the roof's performance over time. Consulting a qualified roofing professional for ongoing maintenance and repairs is advised.

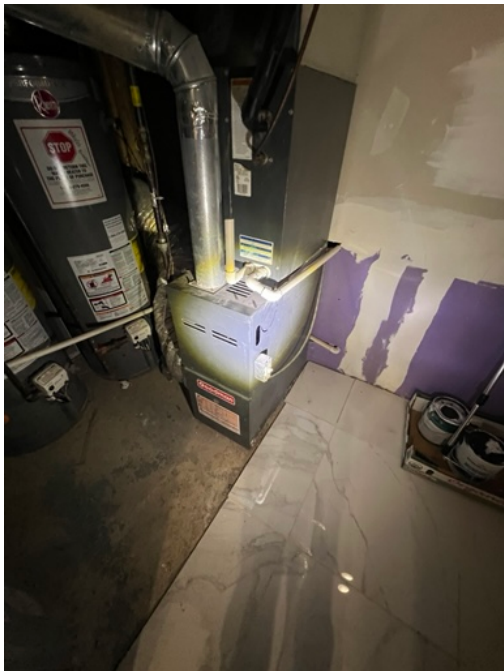
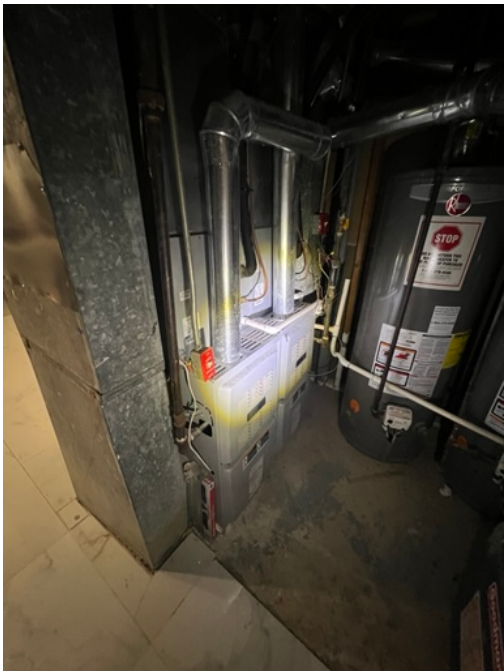
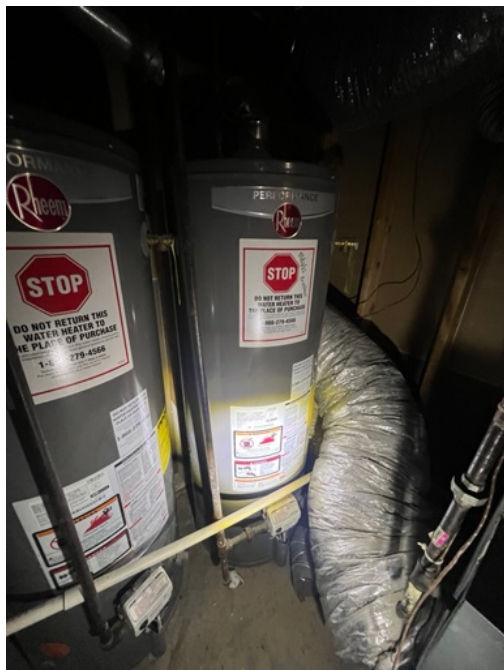
4.1) Unit Conditions

The furnaces were operational at the time of inspection. Routine maintenance and servicing are recommended for proper performance. The inspection of major items is not a guarantee or warranty of future performance or conditions.

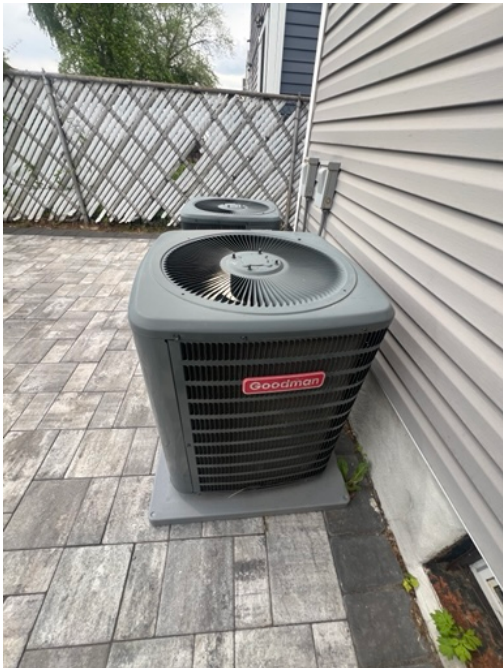
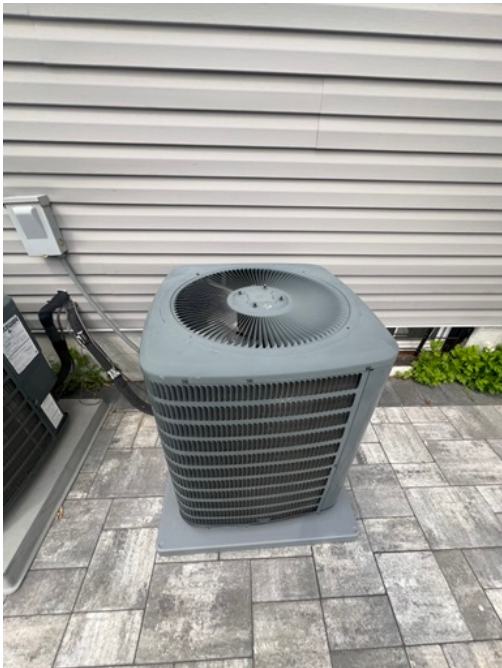
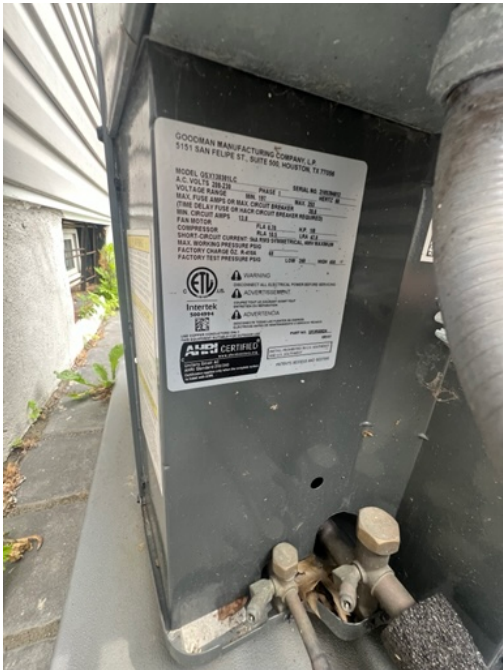
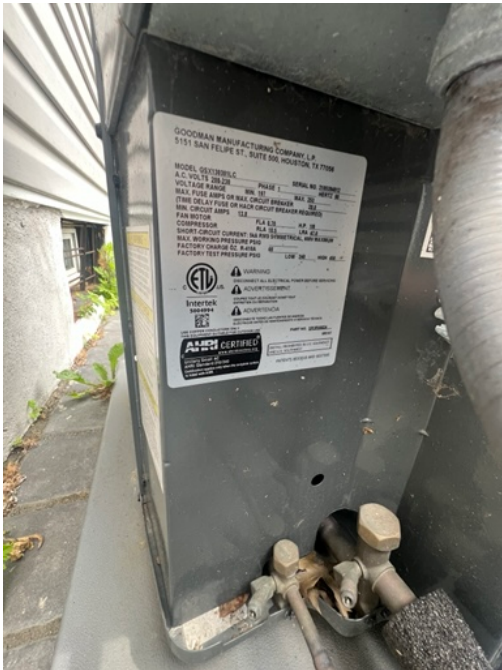
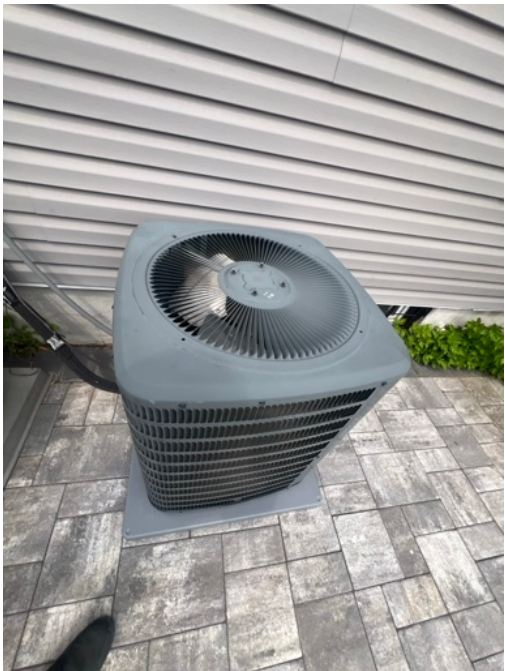
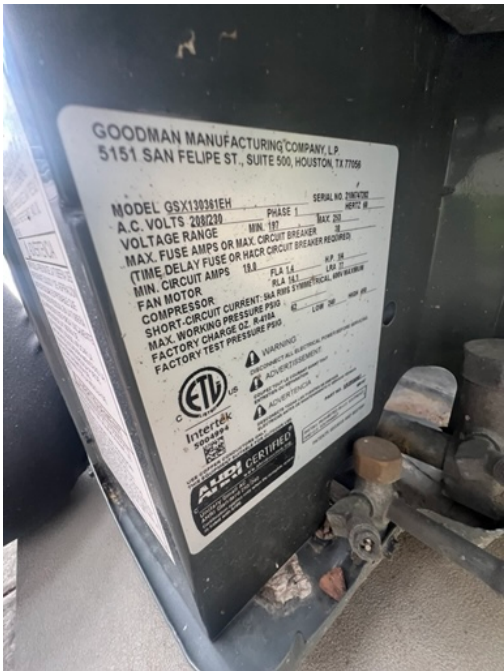
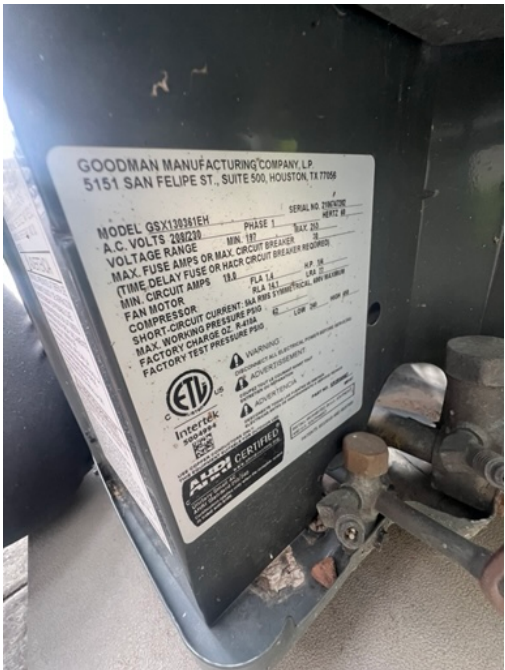
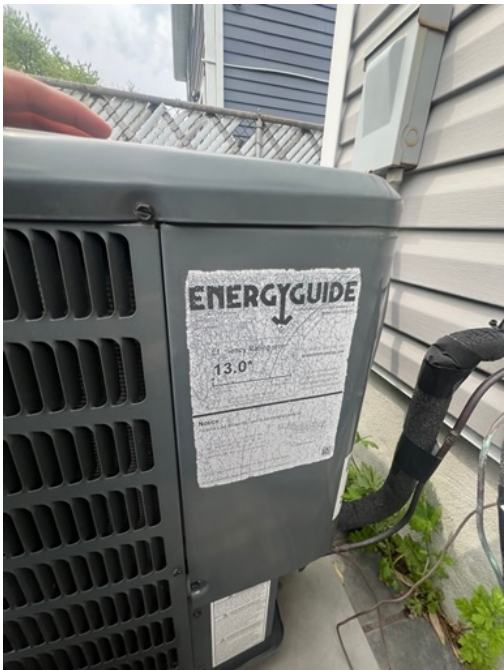
**4.5) AC Unit Conditions**

The air handler appears to be from 2015 and was operational at the time of inspection. An unusual noise was noted from the air handler or blower fan during operation. Service and further evaluation by a qualified HVAC contractor is recommended.

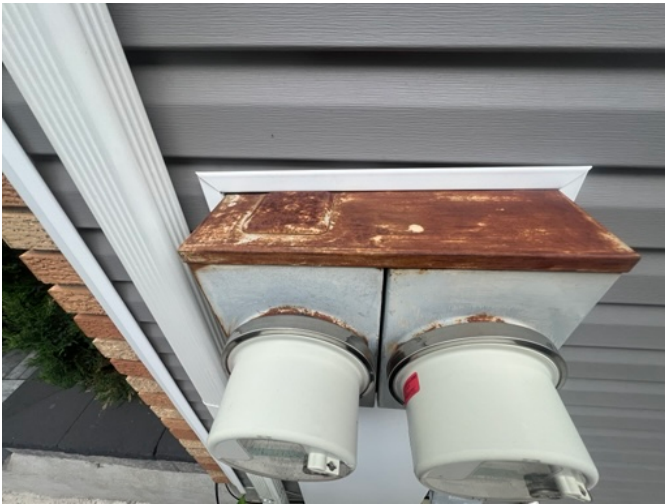
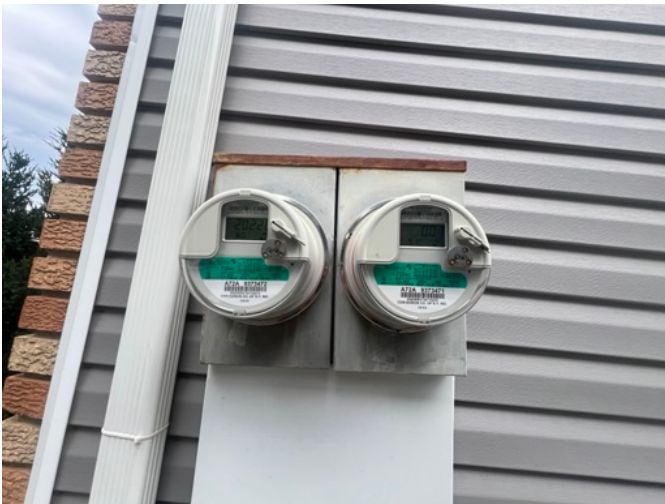
#### 5.1) Electrical Service Conditions

Corrosion was observed. Recommend maintenance as needed.

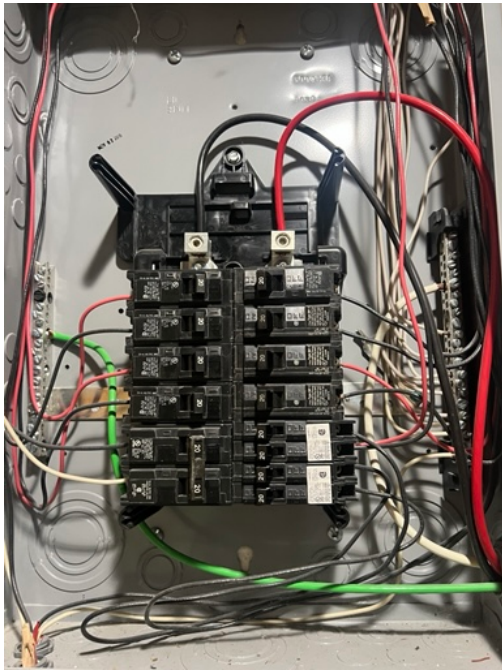
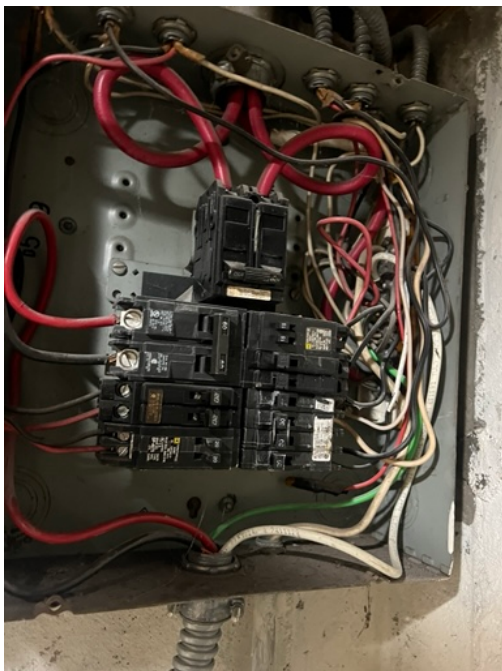
## 5.3) Electrical Panel Conditions

One main panel with a pass through and a subpanel were present at the time of inspection. The panels appeared generally serviceable in the visible areas. Panel covers should be installed or secured as needed for proper safety.

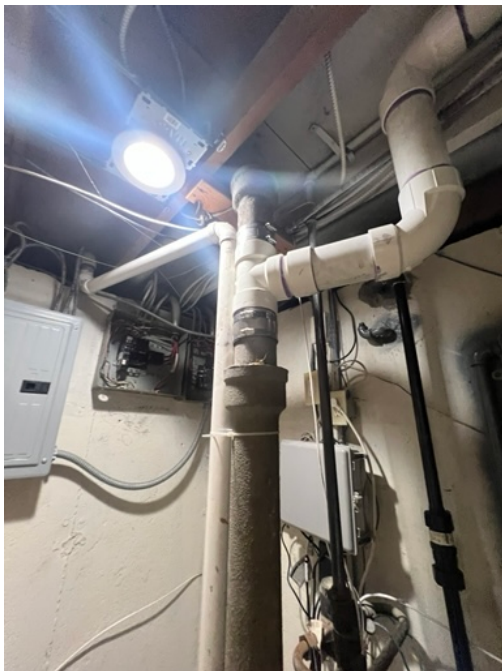
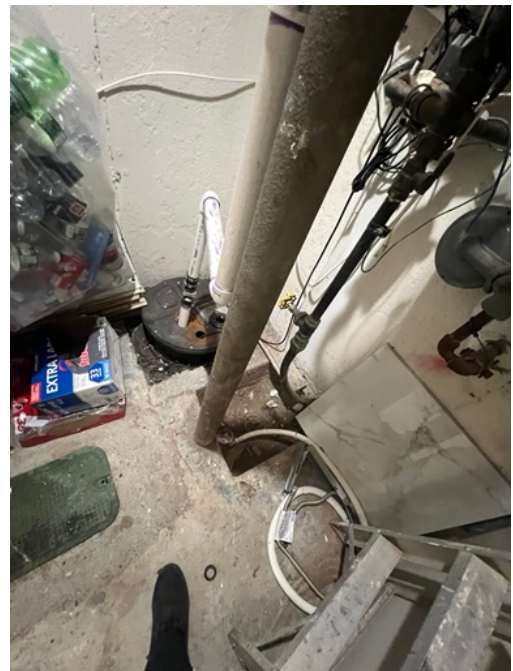
#### 6.1) Main Line & Valve Conditions

The visible portion of the main pipe and valve appeared to be in serviceable condition at the time of the inspection.

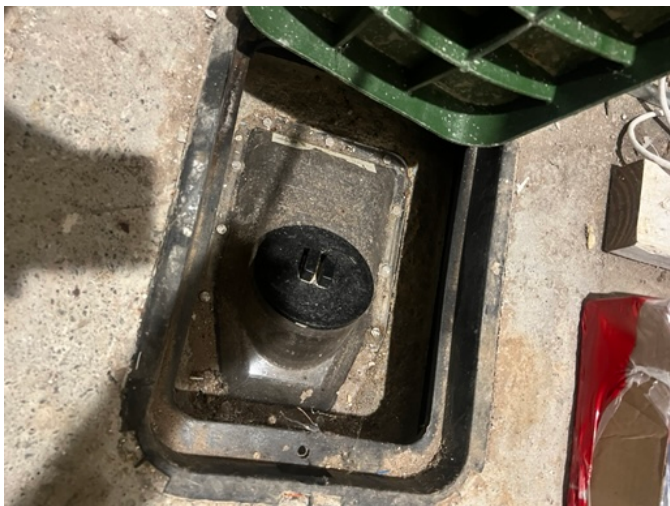
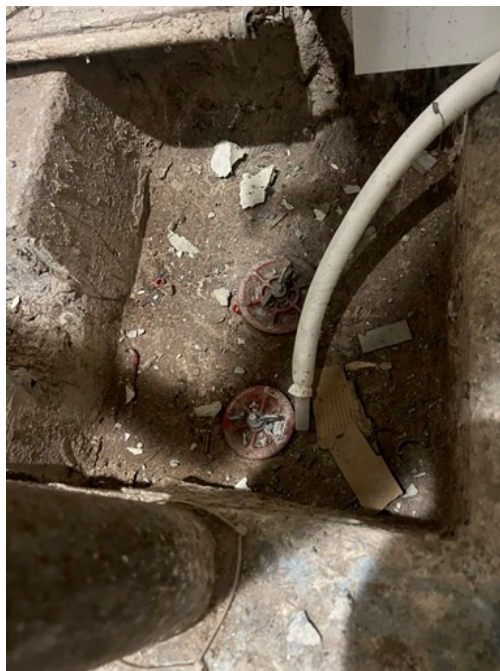
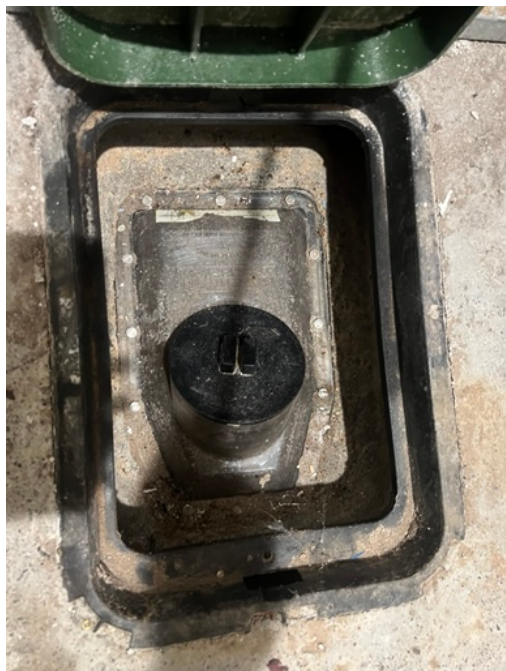
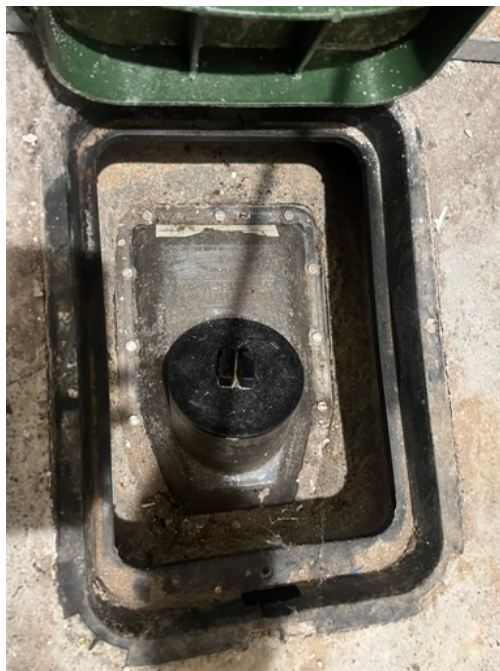
#### 6.3) Drain Line Conditions

The visible portions of the waste lines appeared to be in serviceable condition at the time of inspection. All of the waste lines were not fully visible or accessible at the time of the inspection.

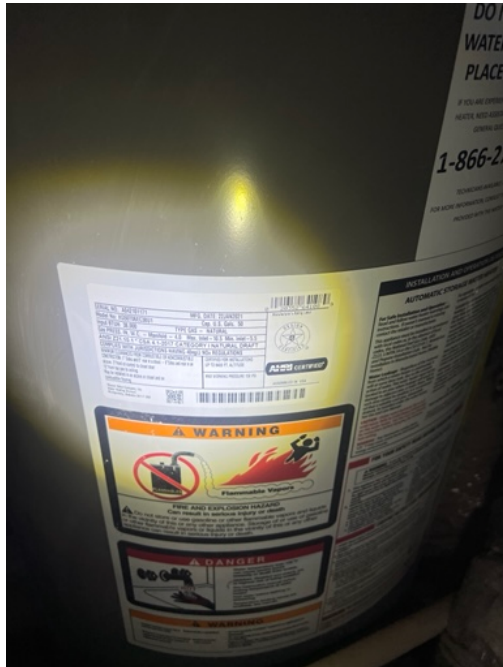
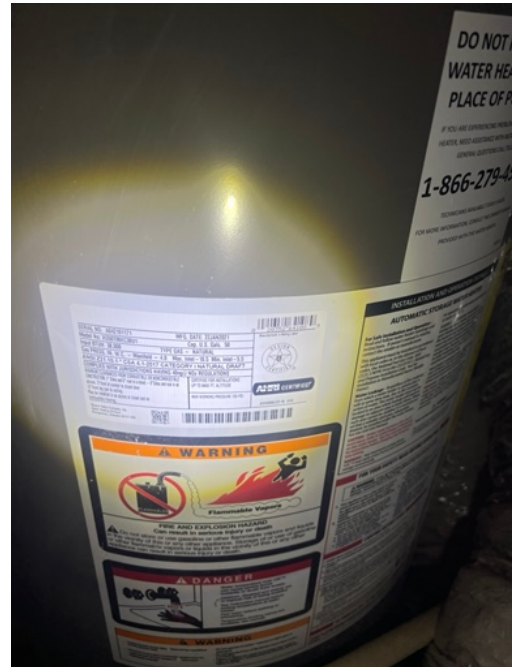
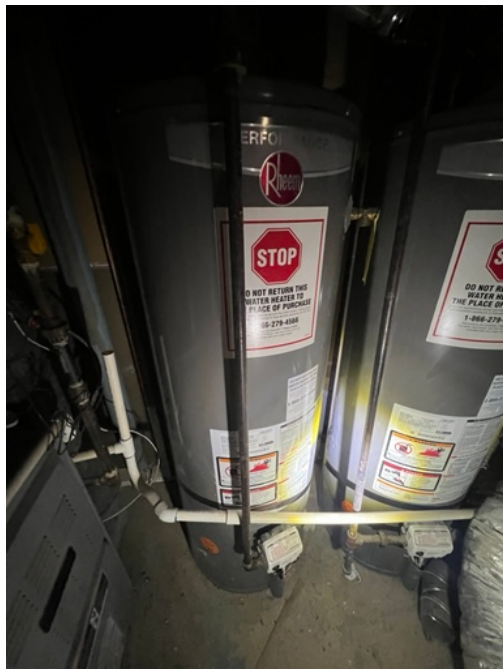
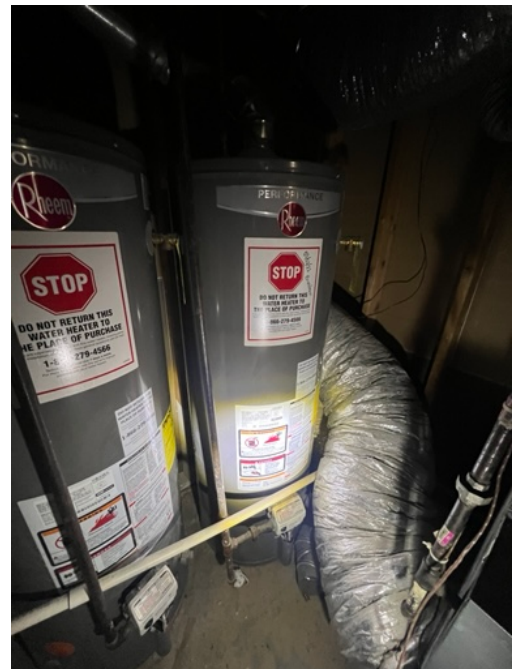
## 6.4) Water Heater Conditions

The water heaters appear to be from 2021 and were operational at the time of inspection. Routine maintenance should be performed as needed. The inspection of major items is not a guarantee or warranty of future performance or conditions.

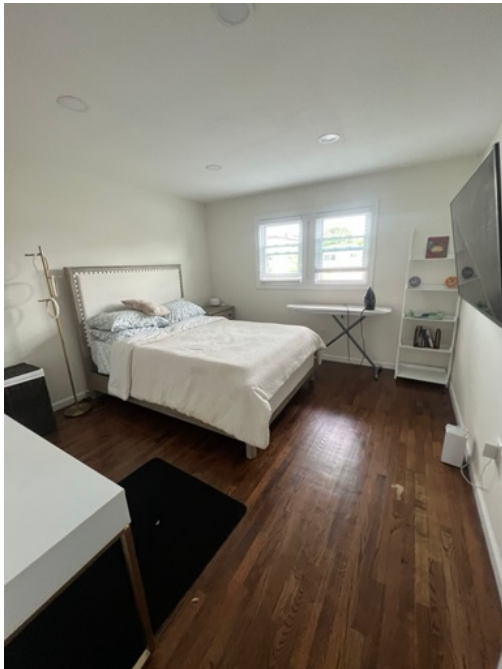
#### 7.3) Floor Conditions

The floors squeaked at second floor. Recommend securing floorboards and / or repair as needed.

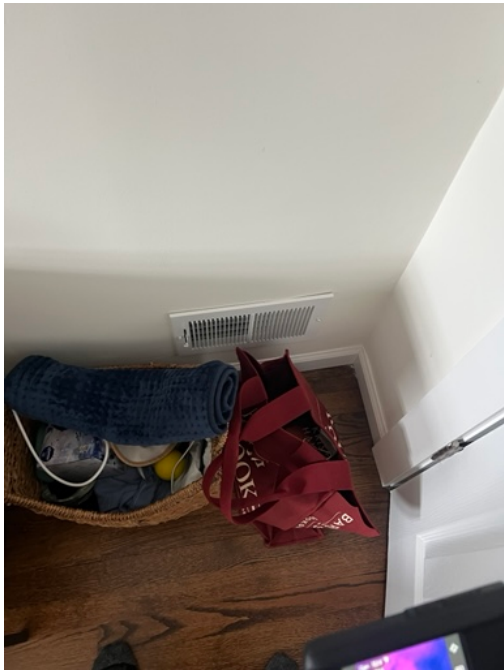
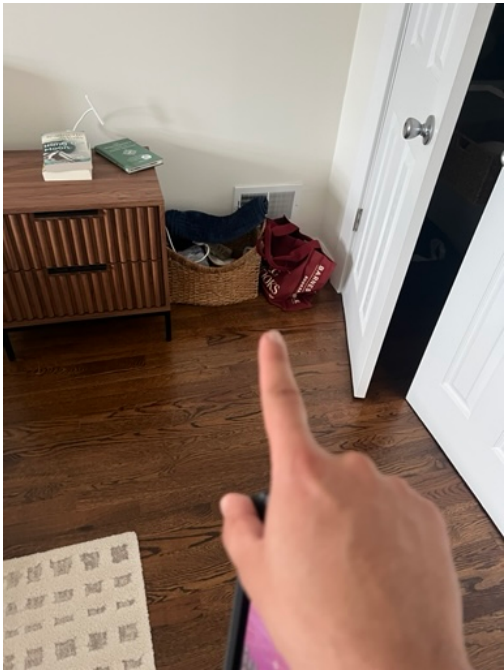
#### 7.4) Heat Source Conditions

Low air volume / flow was noted in bedroom on second floor. Recommend further evaluation by a qualified heating contractor.

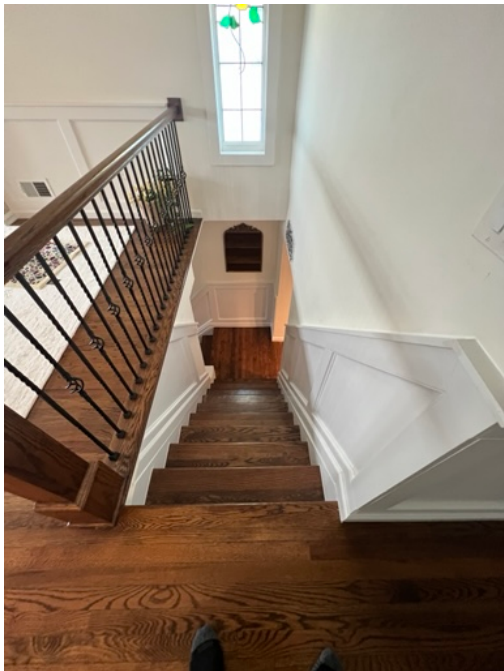
7.5) Railing

A handrail is recommended at the interior wall stair area for improved safety and support. Installation by a qualified contractor is recommended as needed.

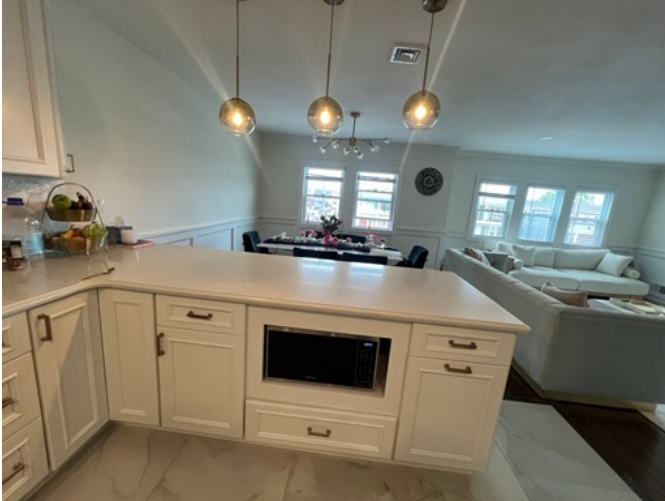
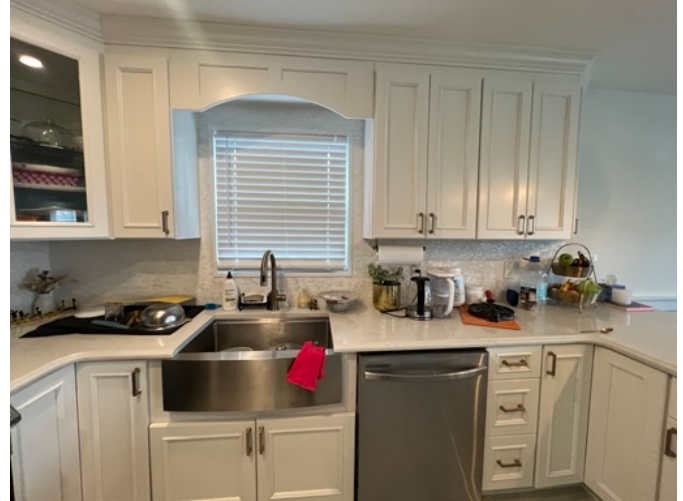
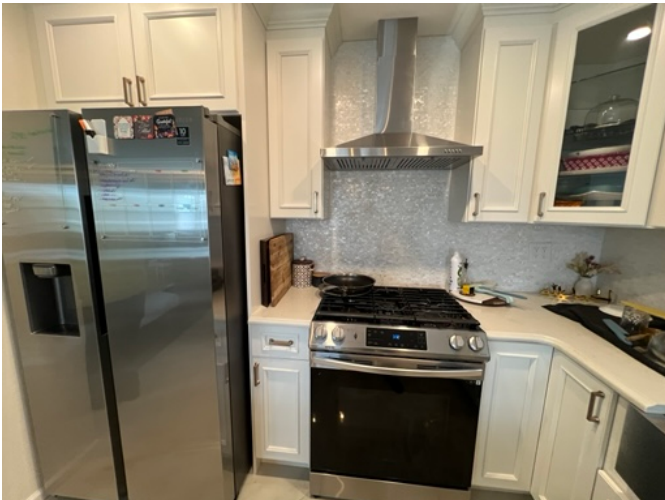
#### 8.1) Wall Conditions

The general condition of the walls appeared to be in serviceable condition at the time of the inspection.
