## Report Summary Page

This is only a summary of the inspection report and is not a complete list of discrepancies.

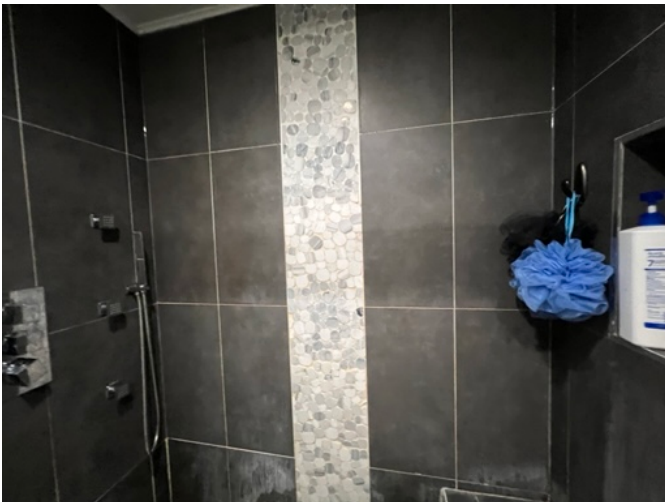
Caulking and / or tile grout is needed at the shower walls and/or floors in bath . (conditions behind walls or tiles were concealed and could not be determined).

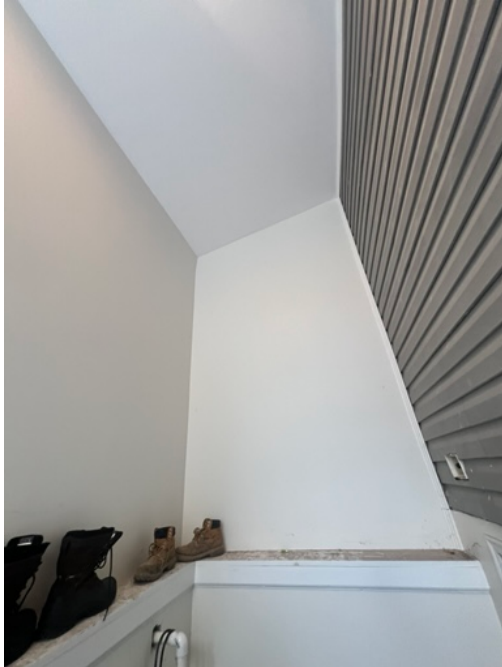
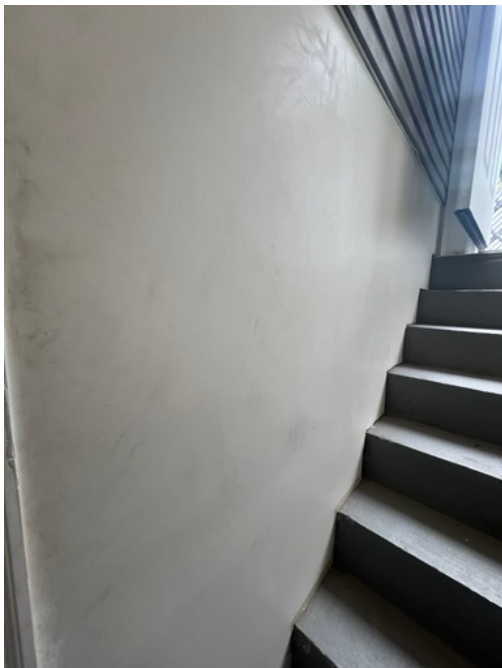
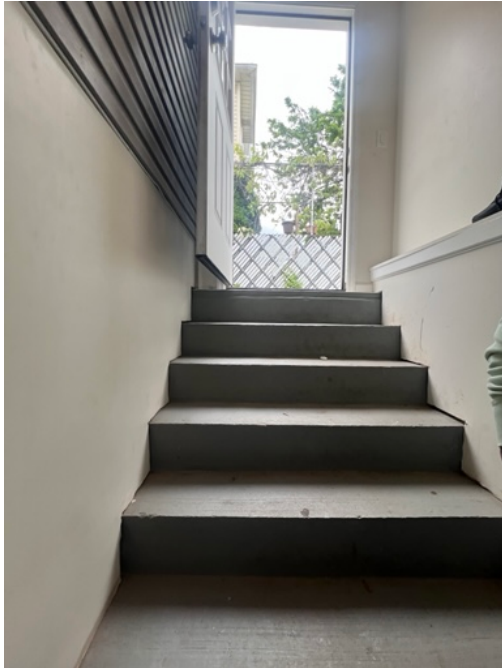
**10 Basement****Walls - Ceilings - Floors****10.1) Basement Stair Conditions****R**

The stair railing was missing or not installed. Recommend installation of railings as a safety measure.

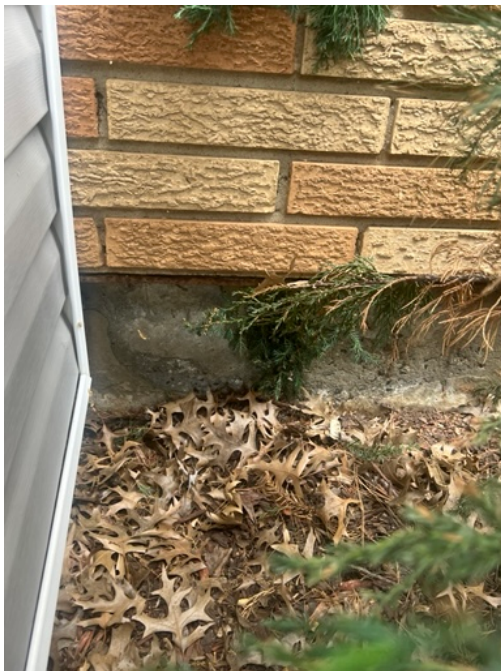
A crack of approximately 1/8" or less was observed in the foundation wall. The cracking implies that some foundation movement has occurred. Recommend masonry sealing and monitoring for any further movement. Although no obvious evidence suggesting "immediate" concern was observed, this does not however guarantee future conditions. The exact / precise measurement of such conditions is not within the scope of our inspection. Past or future movement may be related to soils and geological issues, which are beyond the scope of our expertise.

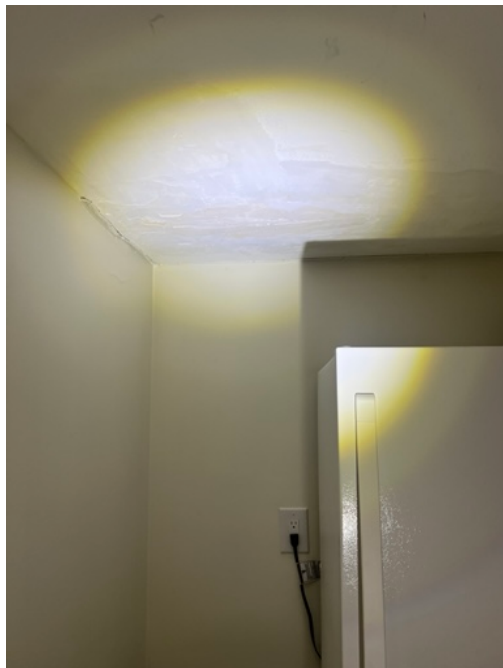
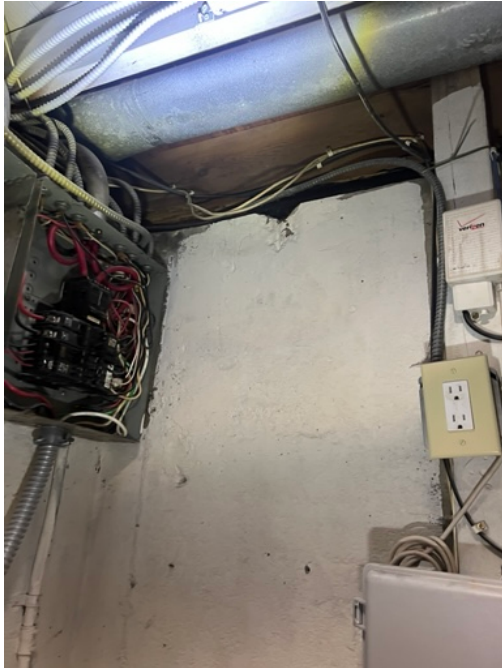
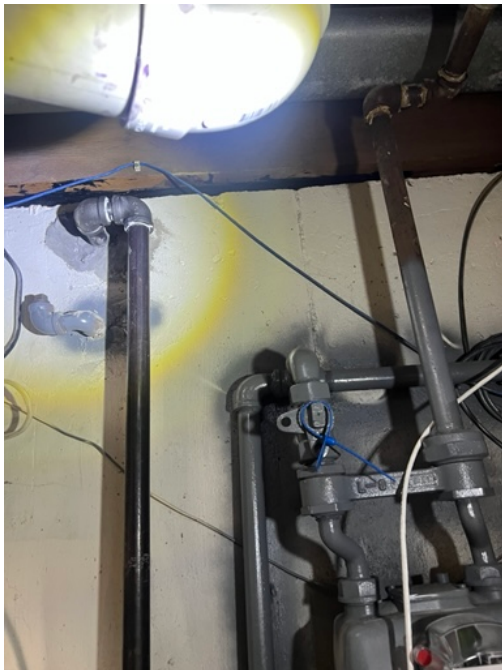
### 12.2) Flooring Support Conditions

Evidence of past leakage was noted in the basement utility room at the time of inspection. Waterproofing or prior repair measures also appear to be present. The area should be monitored and repaired further as needed.
